BUILDING SURVEY

Brockenhurst

**KEVIN SHAW & ASSOCIATES
CHARTERED SURVEYORS**

Inspected on XXXXXXX

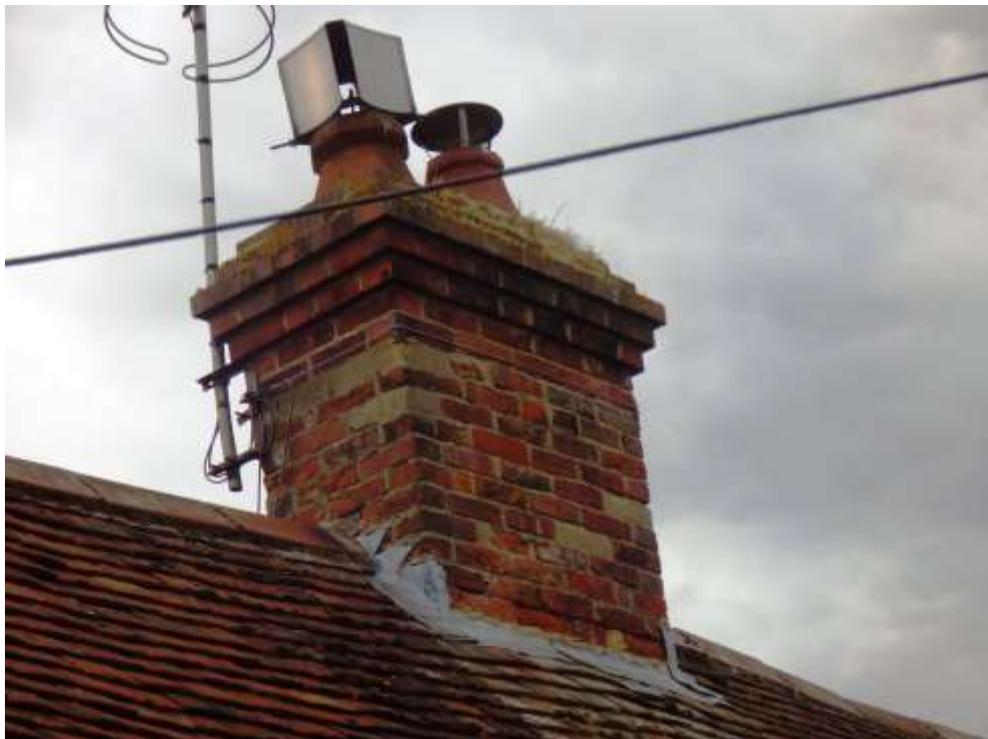
The chimney stack – front view

The stack is surmounted by two chimney pots (one for each property). The pot is fitted with a metal cowl. The stack is sealed to the adjacent tile coverings with a lead apron and flashings.

The chimney is reasonably straight and true with no signs of significant bulging or cracking. The brickwork is in a fair condition with some spalled brickwork noted – probably caused by the use of non sympathetic cement mortar repairs (a lime based mortar should be used with brickwork of this age).

Some localised repairs will be required from time to time, together with replacement of spalled brickwork.

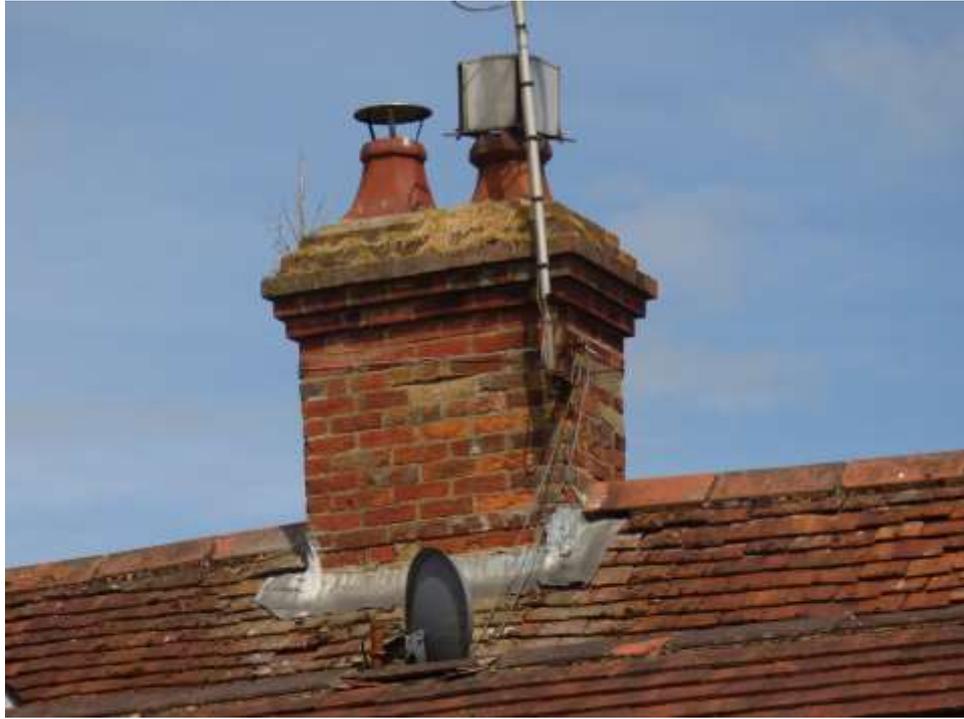
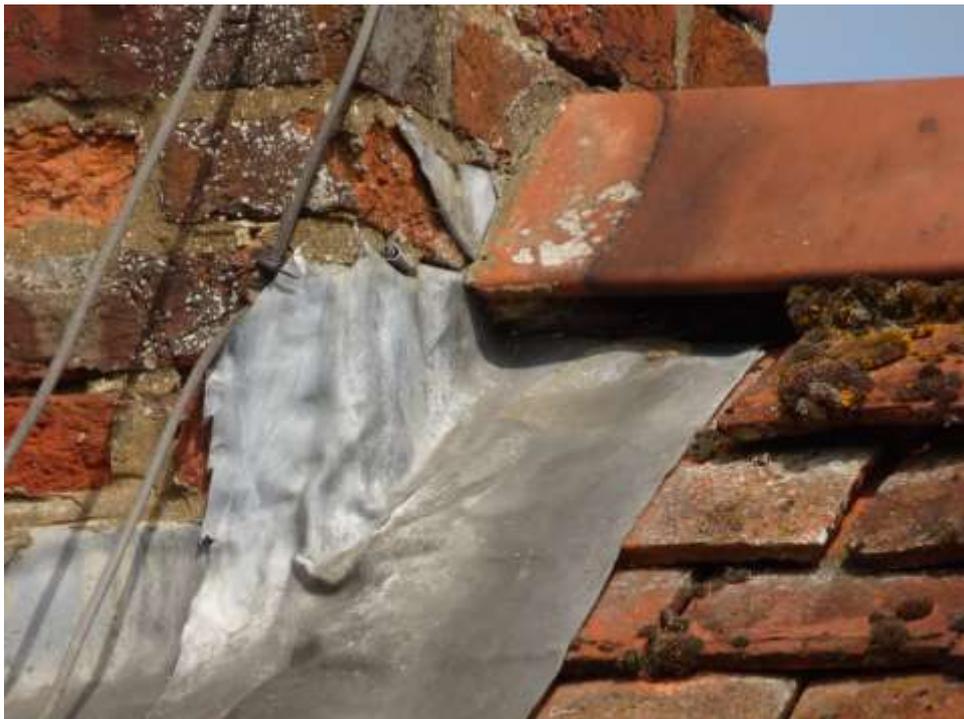
Rear flashing which is poorly detailed – note pointing to ridge tile is deteriorating

The chimney pot is in satisfactory condition although we cannot comment upon the condition of the cement flaunching at the top of the stack. Some plant growth has taken root.

The flashings are in a reasonable condition, although the sections to the rear have been poorly fitted. When repairs are carried out to the chimney/roof we suggest this section is replaced.

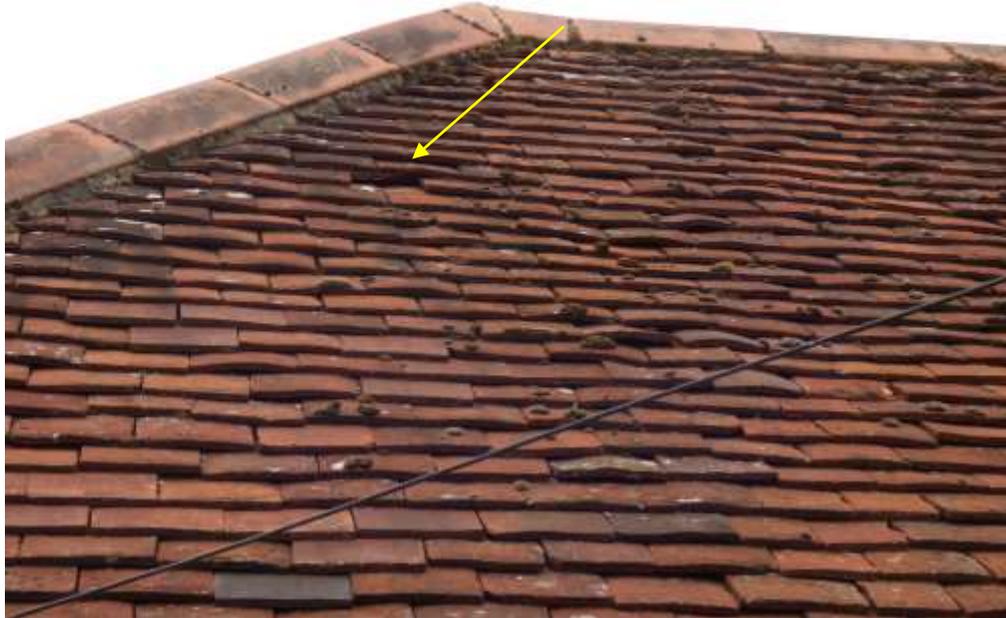
The roof tiling is in reasonable order considering its age, although inevitably there are a few slipped, missing and broken tiles, which will need replacement. In view of the age of the roof, ongoing replacements must be expected.

Close up of front roof – there is the odd missing or slipped tile

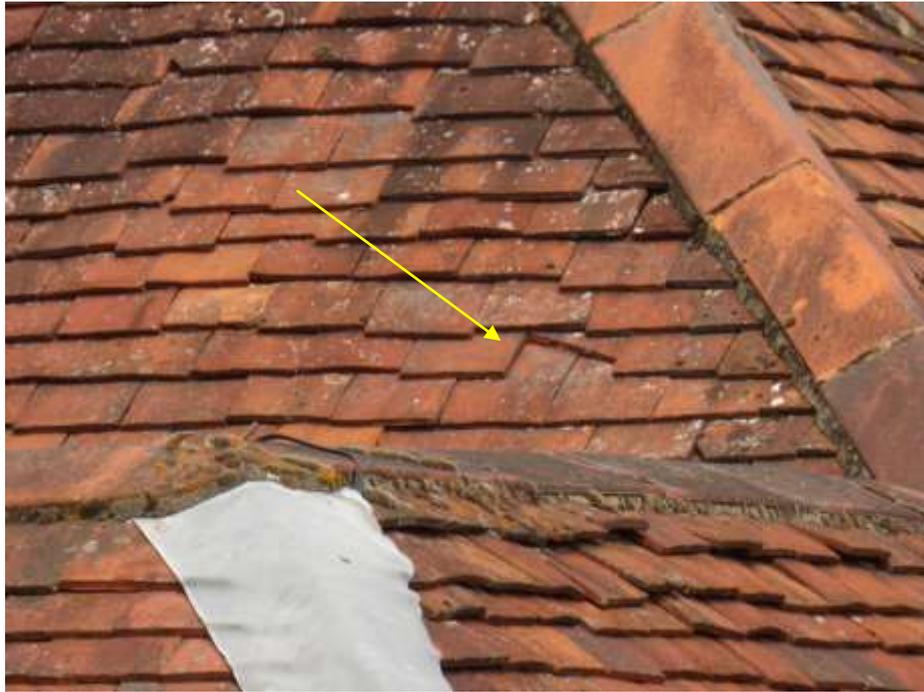
Close up detail – showing the odd chipped or slipped tile

Whilst all ridge and hip tiles were noted to be in place the mortar pointing is cracked and weathered in places. No urgent repairs are required at this stage, as none of the tiles appear to be working loose. However these tiles are often dislodged in high winds and for safety they should be periodically checked and re-fixed, as found necessary.

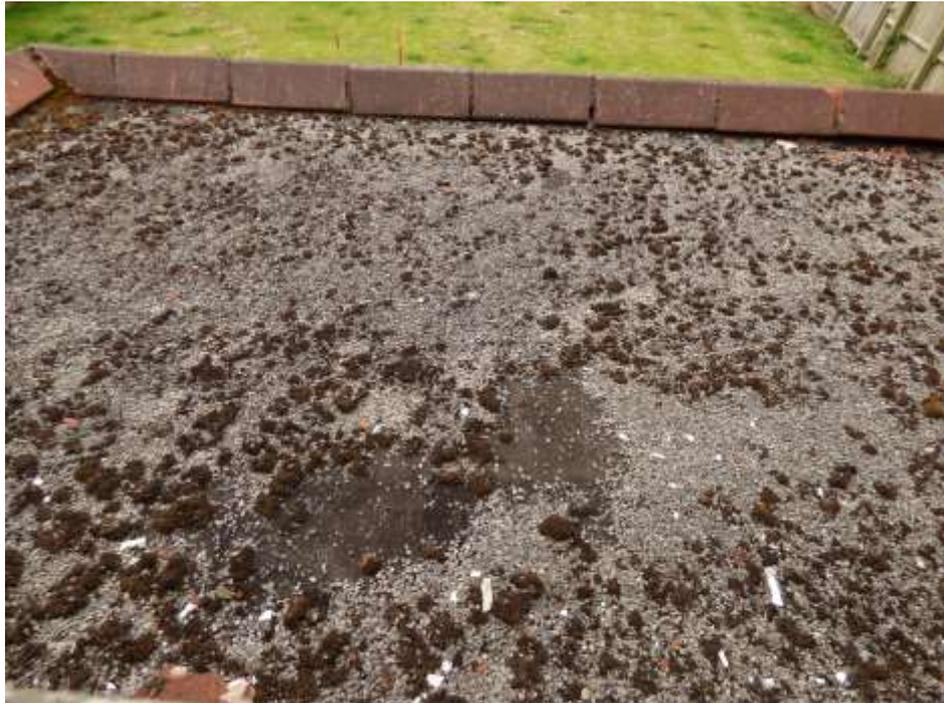
Lower rear flat roof – covering is clearly of some age

We believe that the flat roofs to this property has been in place for some years with evidence of moss growth. You should anticipate an above average maintenance/ renewal liability with this roof. The roofs should be monitored regularly and repair / recovering undertaken immediately at the first sign of any future failure.

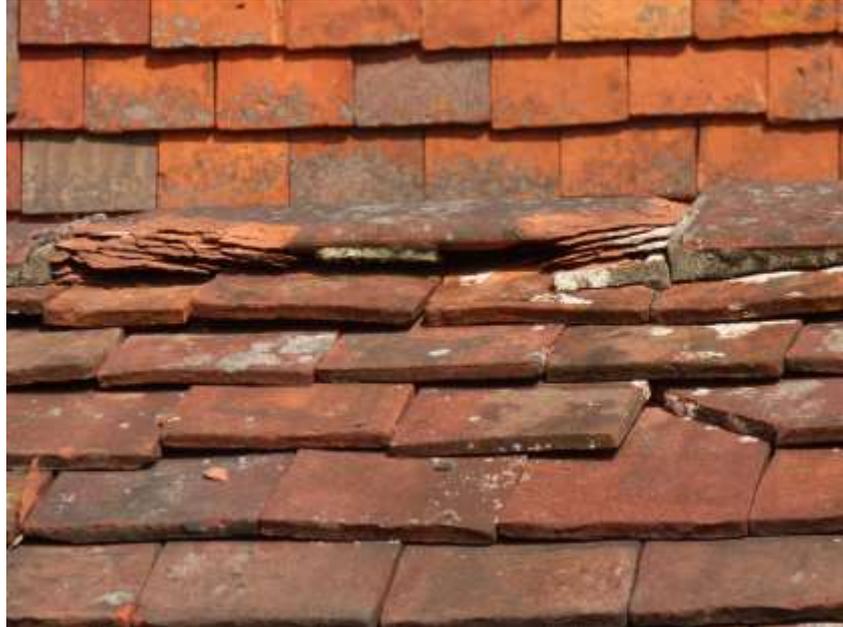
Damaged ridge tiles to flat roof perimeter (lower flat roof)

The tile perimeters are in fair condition, but like the main roof coverings ongoing maintenance should be anticipated. Some repairs are required to the ridge tiles which appear to have been damaged by a ladder.

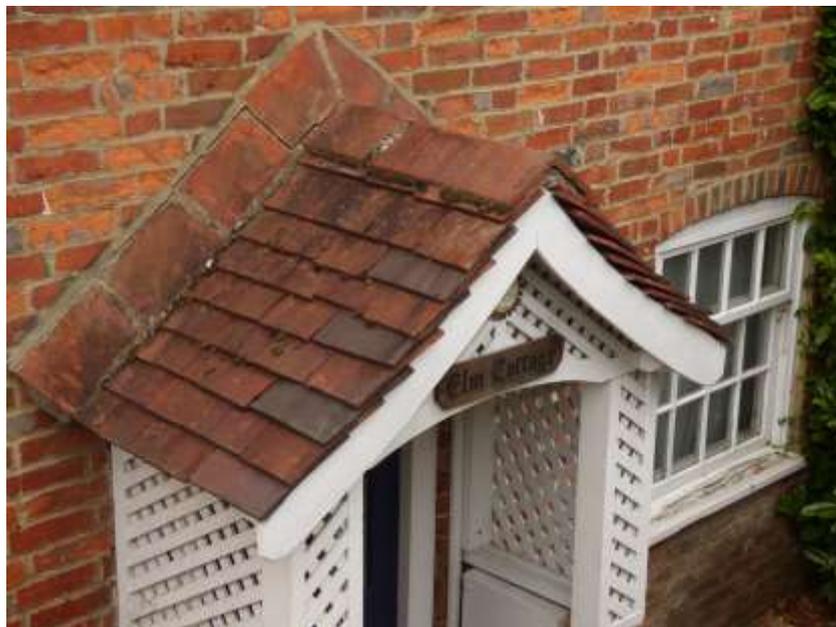
Porch canopy roof

The porch canopy roof is in a reasonable condition. The tile flashings which seal the roof to the adjacent walls are not as effective as lead flashings however it is unlikely that the Conservation Officer would approve of their replacement as this would alter the appearance of the property.

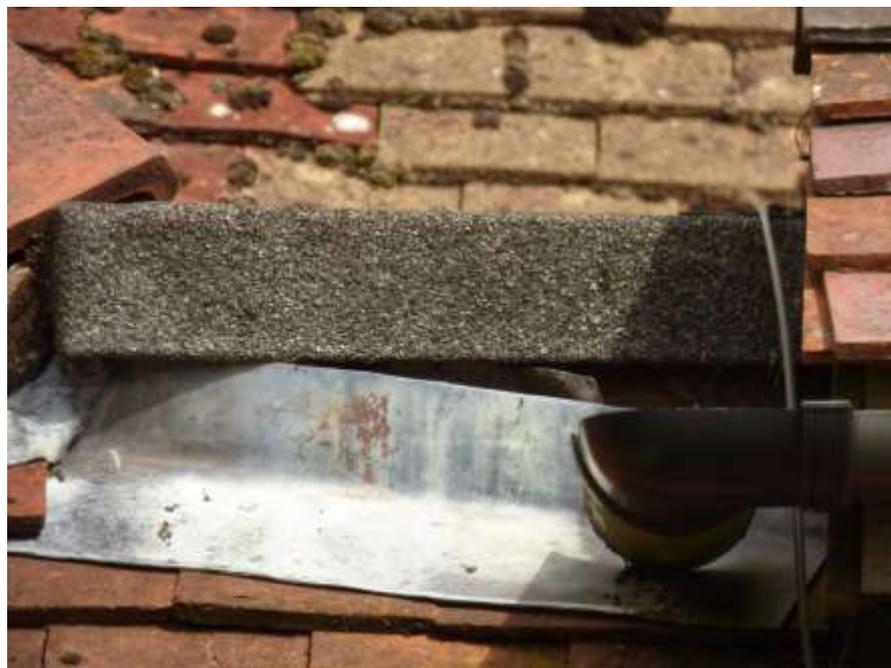
The metal flashing beneath the felt has slipped and requires re-securing in order to prevent problems with damp penetration

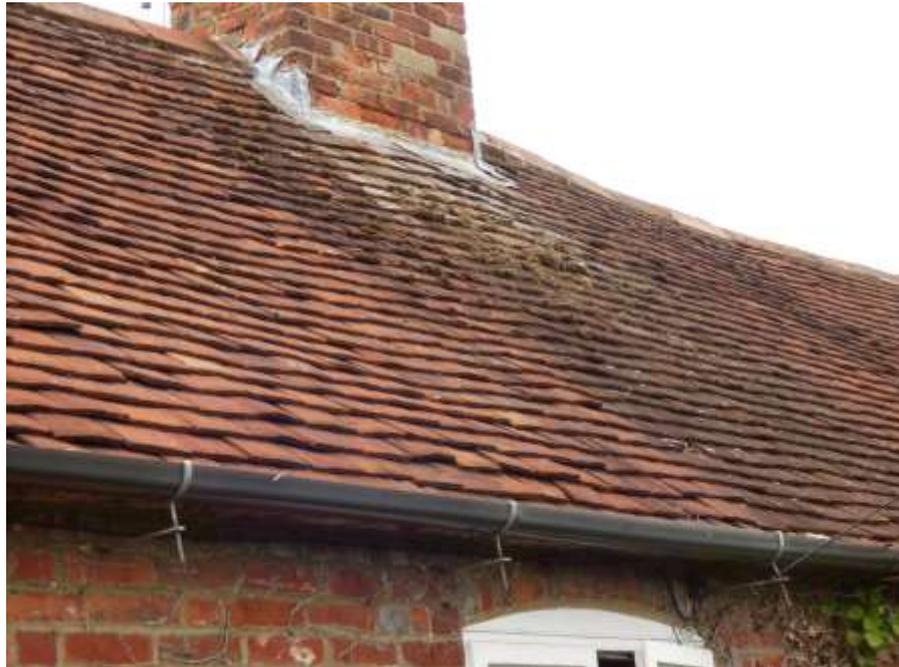
Whilst the rainwater fittings appear to be in a reasonable condition we should point out that plastic rainwater goods are generally regarded as inappropriate for use on a listed building. Consequently the Conservation officer may wish to see the fittings replaced in a more sympathetic material (ie cast iron or lookalike cast iron).

It is essential that the creepers growing to the front are regularly cut back or preferably removed to minimize blockages.

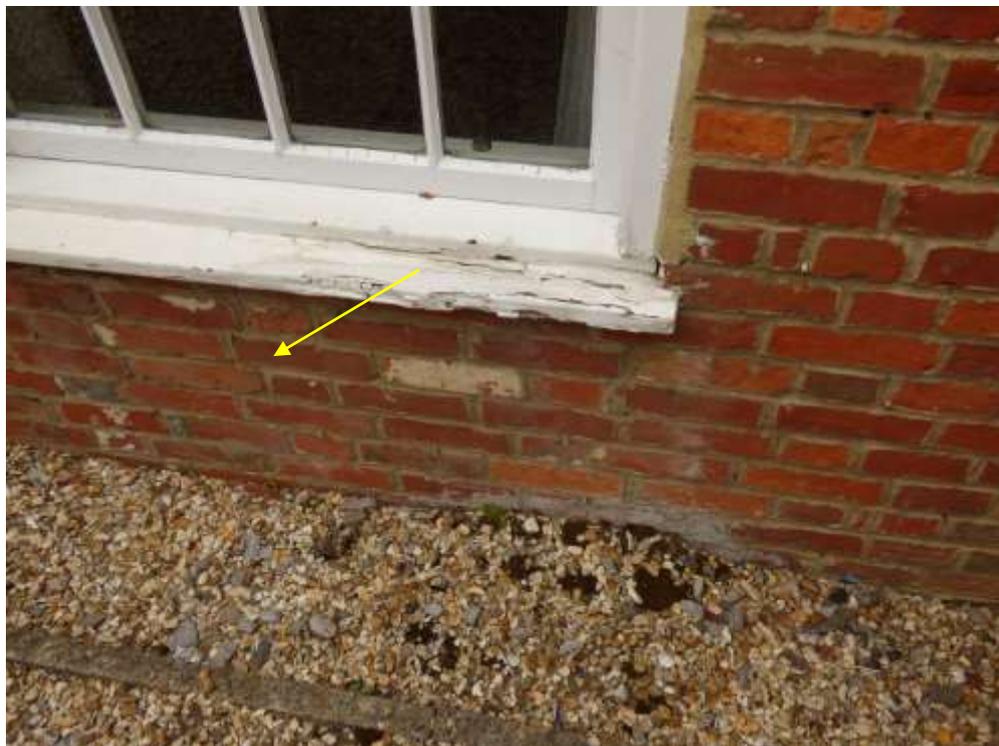
There is a small vertical crack to the front wall of the property below the window. The crack is likely to be due to thermal movement and is not considered structurally significant.

Vertical crack below window (not clearly visible in photo)

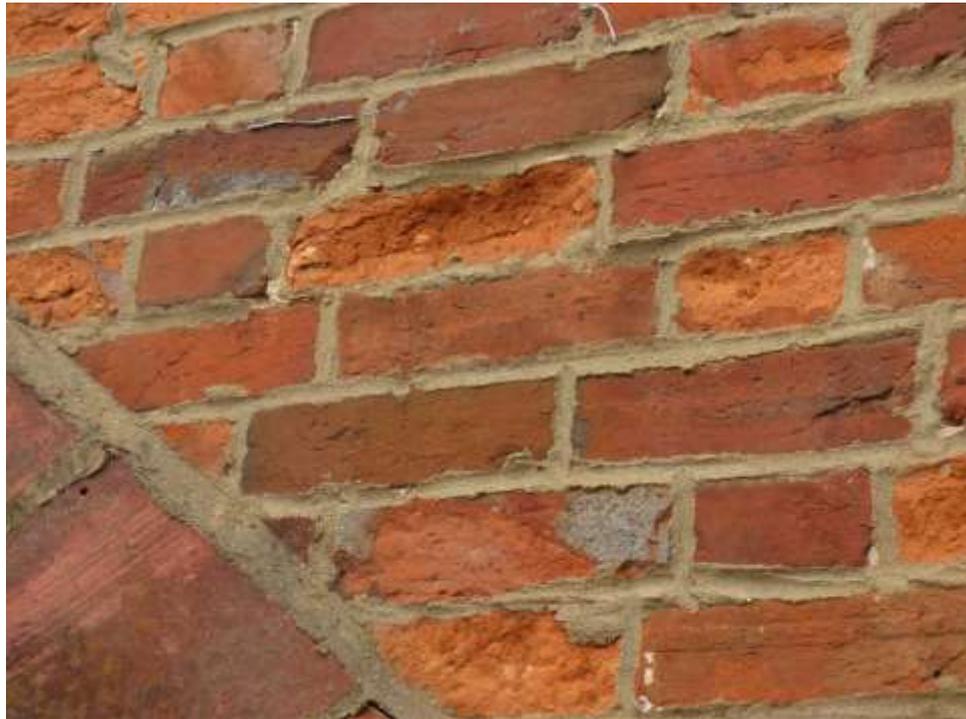
Spalled bricks – caused by the use of a non compatible hard cement mortar.

With solid brick walls it is important to use a lime mortar. A lime mortar is more flexible than a hard based sand cement mix and allows the walls to “breathe”. Unfortunately a cement based mortar has been used. Cement mortars cause the bricks to spall where moisture is forced out through the brick rather than the pointing. This has occurred in some areas and in the medium term some bricks may have to be replaced (consulting beforehand with the Conservation Officer).

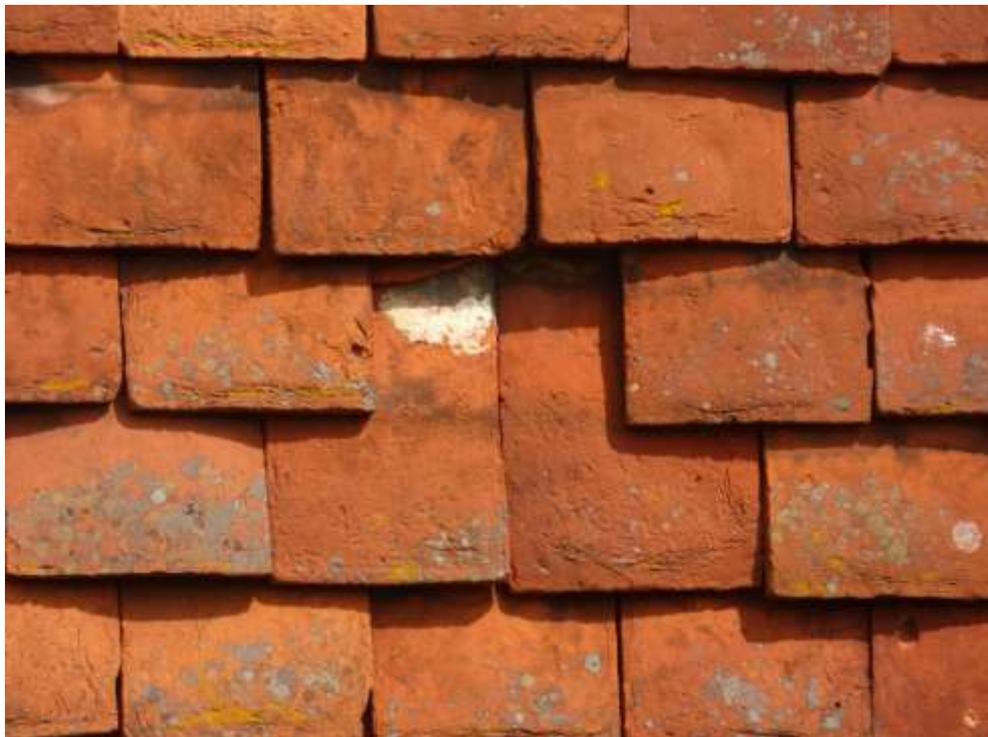
External surfaces must be maintained in weather tight condition to prevent deterioration of the timber work behind. Some of the tiles have slipped and should be replaced.

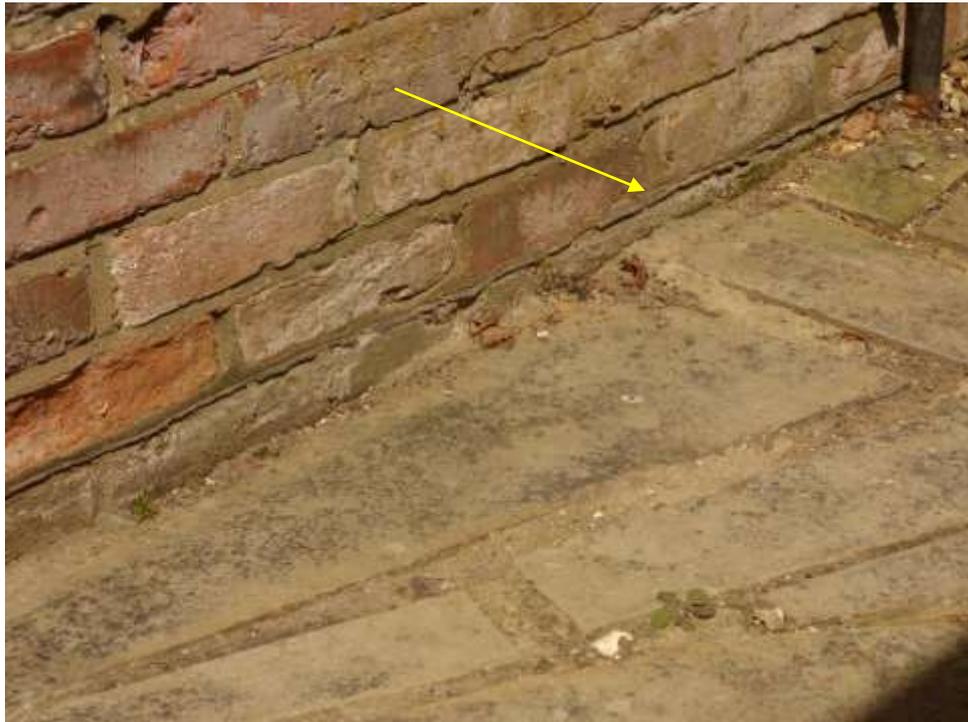
High external ground levels are the principle cause of dampness in older buildings. The levels around the subject property have crept up over the years and are too high, being level and in some areas, well above internal floor level. This is highly unsatisfactory and it is essential that the external levels are lowered as soon as possible, ideally to around 150mm below damp-proof course and internal floor levels. As ever with an older house, this ideal may be difficult to achieve and it is important that the footings are not exposed, as this could cause drying of the sub soil which could lead to structural movement.

High external ground levels to flank wall – arrow points to the DPC

In order to reduce the level of external ground levels without having to cause extensive disruption to external paved or tarmac areas, it is possible to create a small trench around external wall surfaces. This will entail cutting back of tarmac or paved areas and digging a trench around the external walls so that a clearance of at least 150mm is maintained between the damp-proof course and ground levels. This trench can then be back filled with a permeable material such as pea gravel. This will allow an adequate clearance between the damp-proof course.

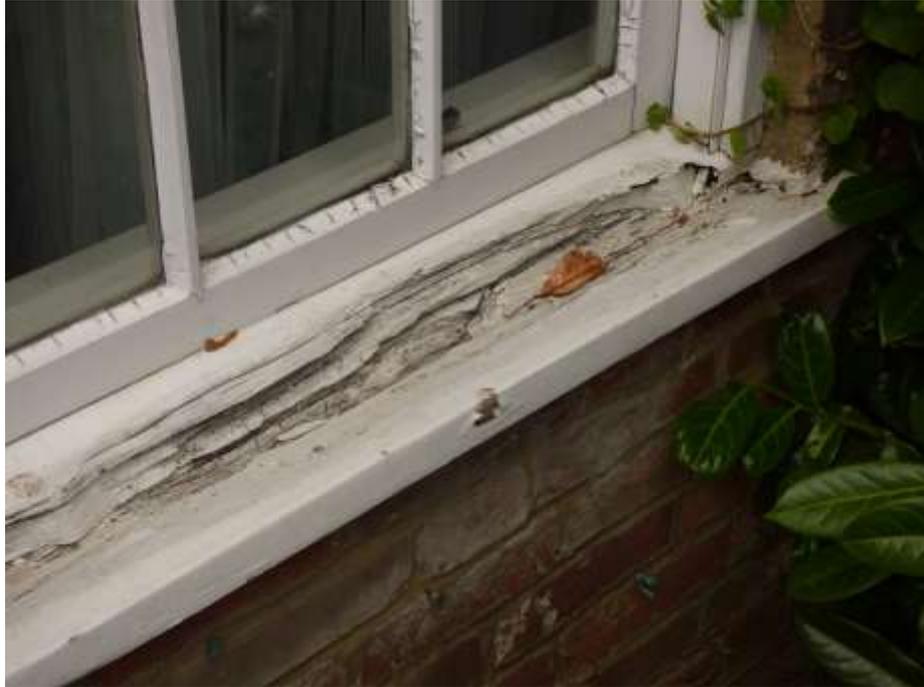
Rot to timber cill

The external joinery has been neglected and decay was noted to many of the windows particularly the cills.

It should be possible to salvage some of the windows however most of the window cills will need to be replaced. Alternatively consideration could be given to replacing the windows with better quality hard wood units. Being a listed property double glazing is unlikely to be acceptable.

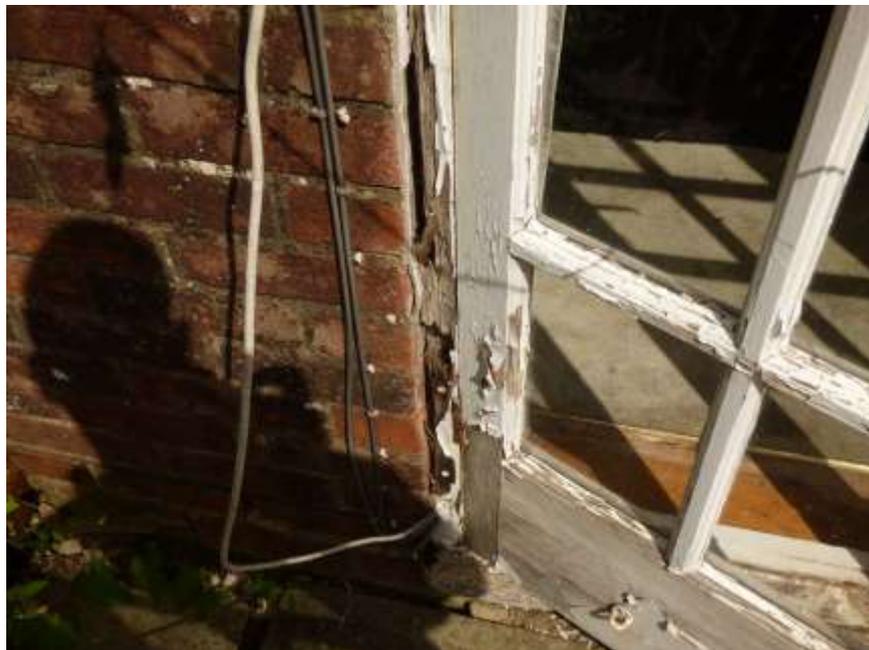
Rot to French door frame

The kitchen and French doors are in poor condition and will need to be replaced together with their frames. Replacement door frames will need to be installed by a FENSA registered contractor or Building Regulation approval obtained.

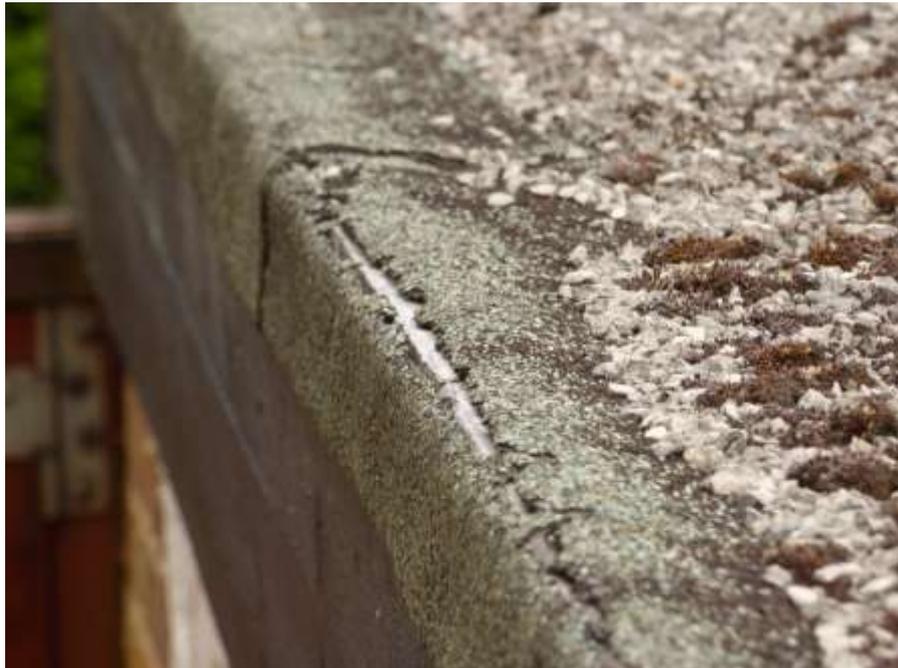
Deterioration to garage roof

No serious defects were noted in respect of the main elevations. The felt cladding to the roof was noted to be generally worn but with no evidence of damp penetration at the present time. The underlying ceiling was tested with a moisture meter and found to be dry. An above average maintenance/renewal liability will apply to this roof.

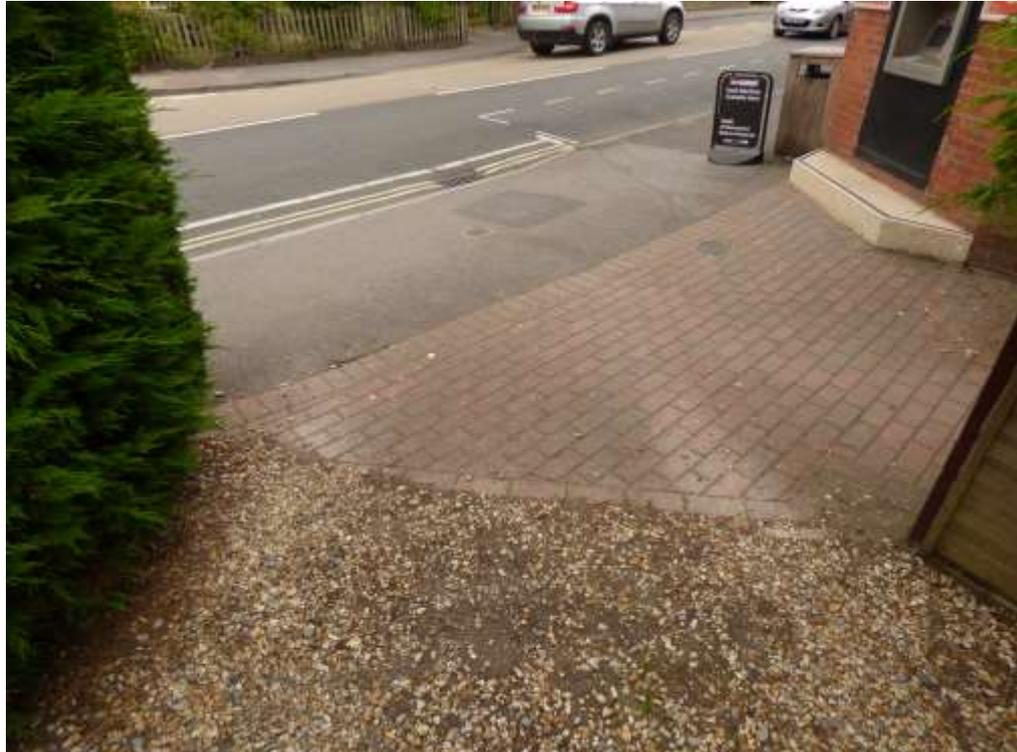
The property is approached via a small gravel driveway. The entrance to the driveway appears to cross over the neighbouring property. This should be verified by your Legal Adviser – if so rights of way and maintenance liabilities should also be confirmed.

Boundaries /rights of way should be checked

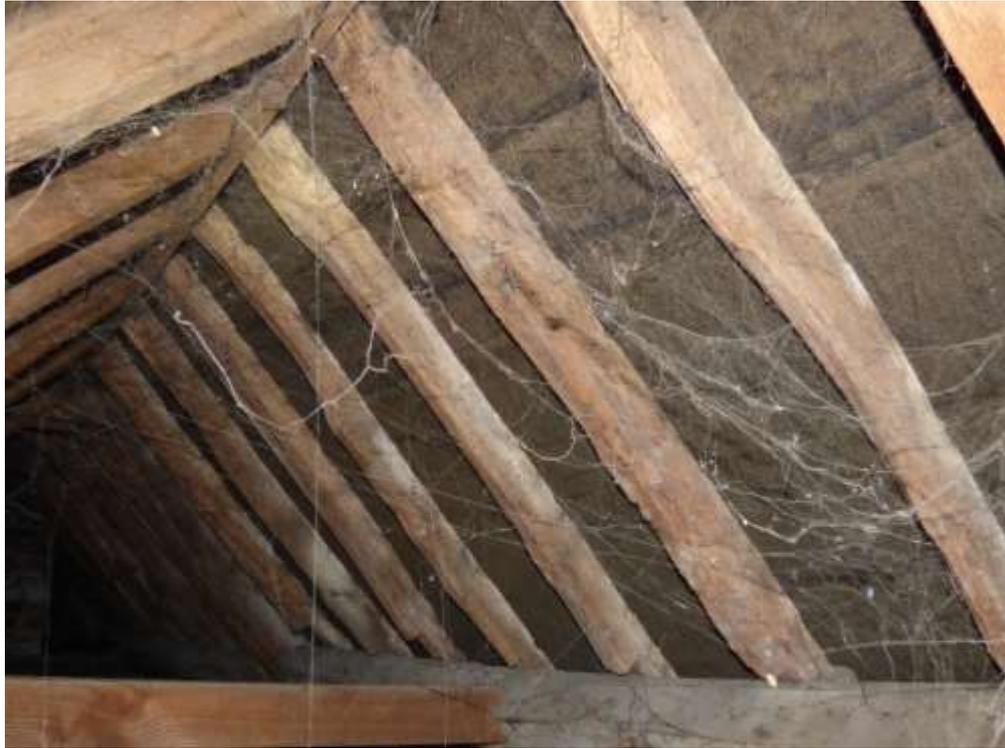
Original rafters overlaid with a non-permeable roofing felt

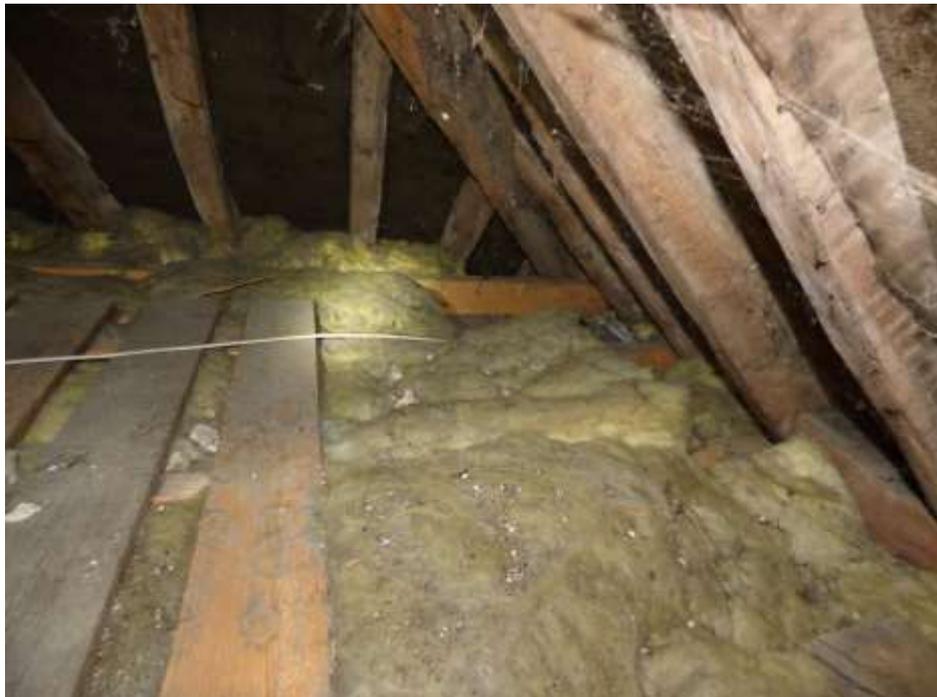
Existing insulation within the main roof space comprises a mineral fibre quilt approximately 100mm in thickness. Current recommendations are for 270mm of this material.

Mineral fibre quilt insulation – not recommended in older roofs such as this

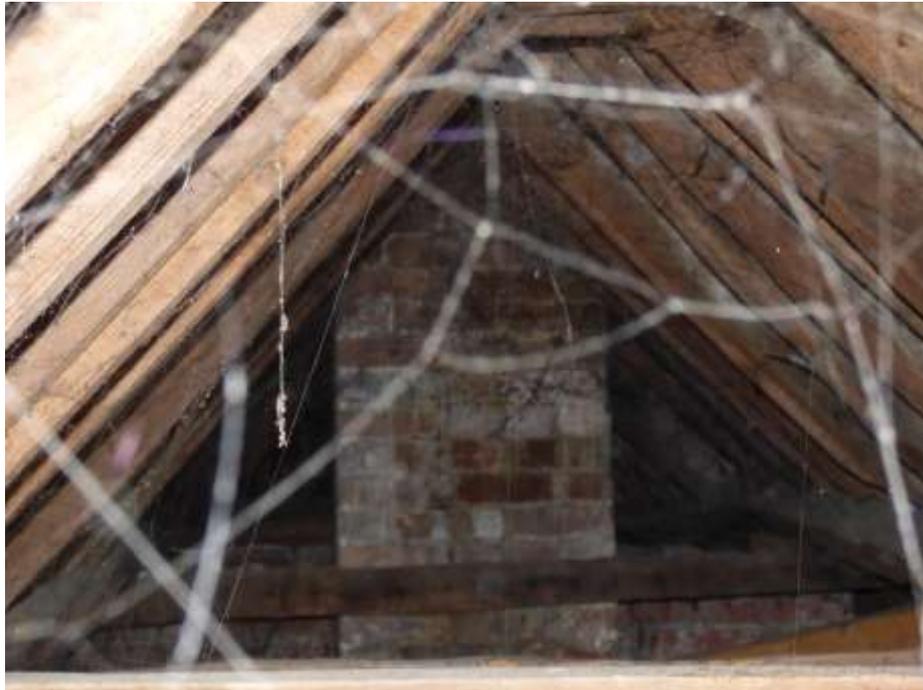
Gaps in party wall either side of chimney breast – a potential fire hazard.

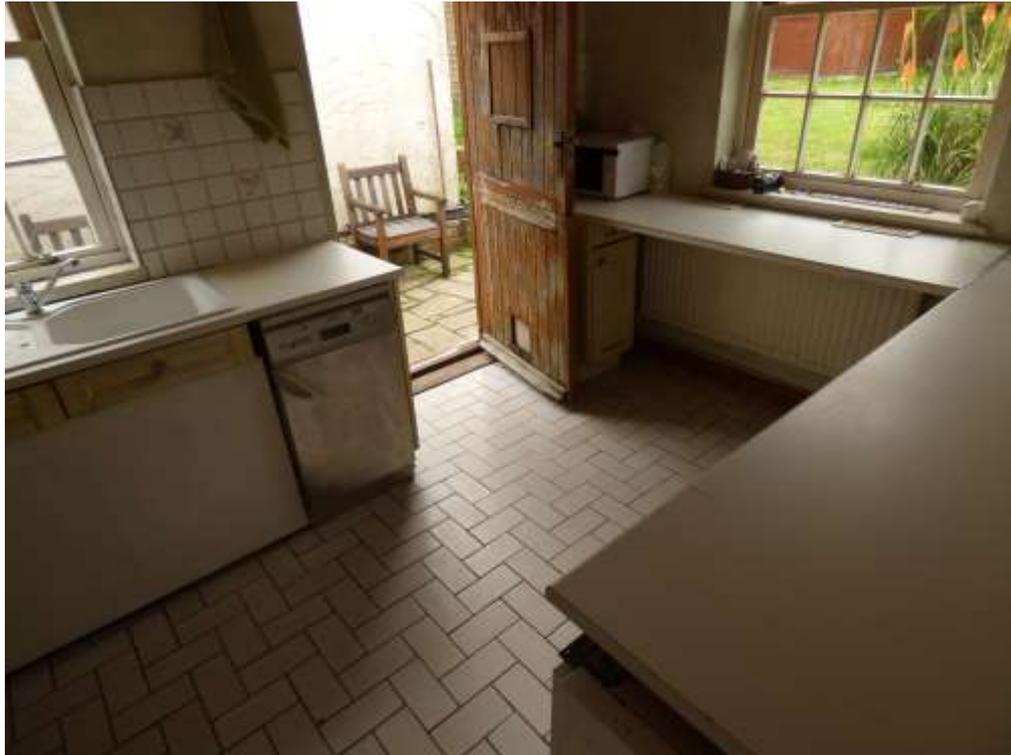
In the kitchen there is a range of fitted wall and base units with laminated work surfaces. These are in poor condition.

Dated kitchen

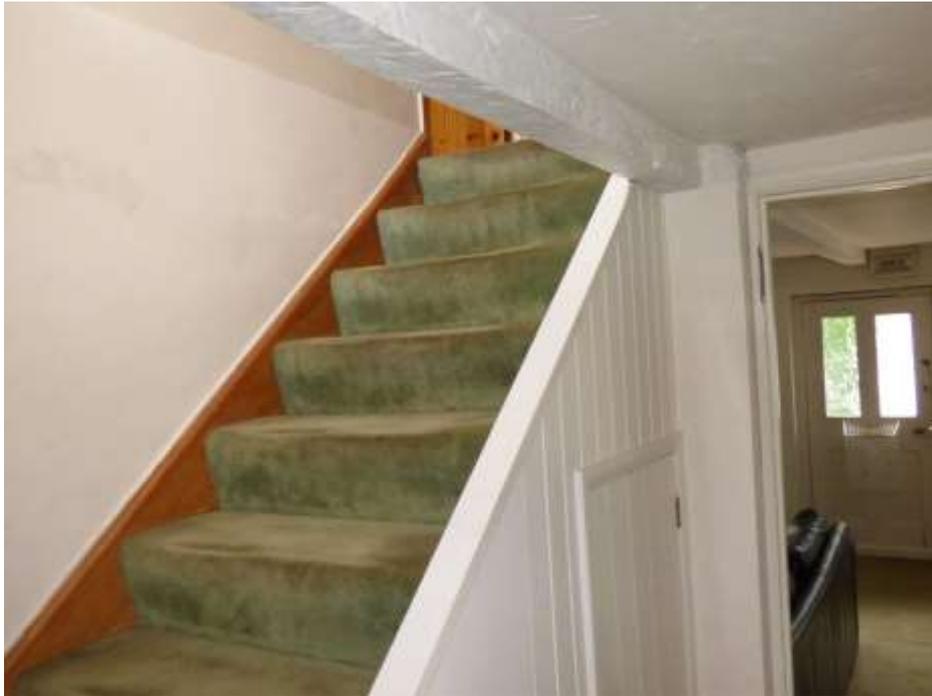
No undue flex or bounce was noted. However, the balustrade to the first floor landing is loose and requires re-securing. There is no balustrade to the main flight which could be a potential hazard for small children.

The stairs are a potential hazard to small children due to lack of balustrading

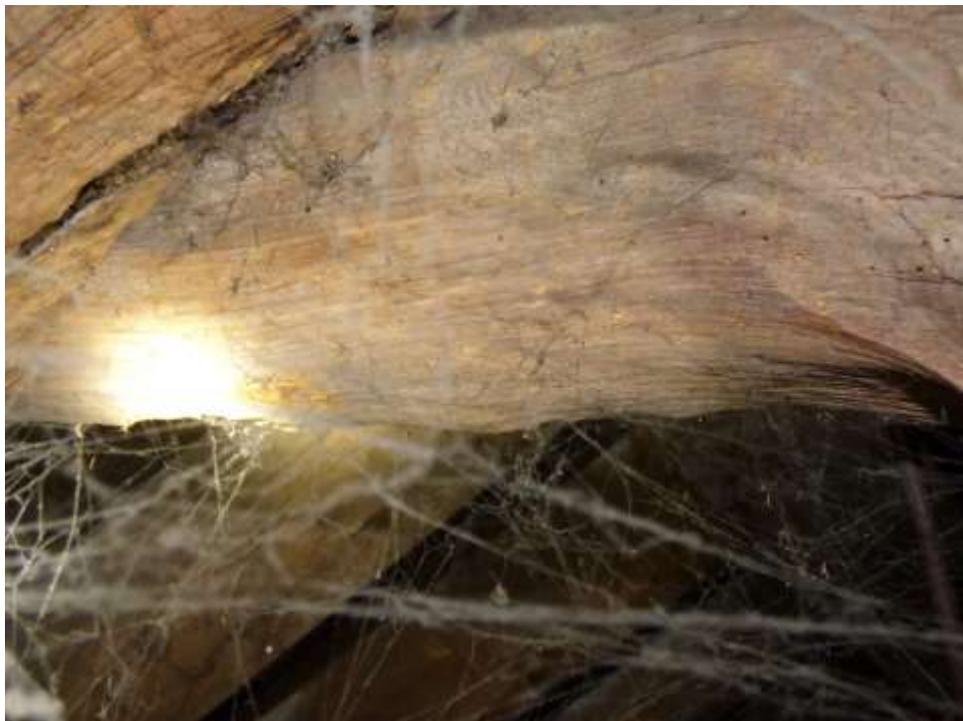
We found evidence of beetle infestation, (bark borer and common furniture beetle) within the main roof void. Most of the infestation appears historic however there are signs of more recent infestation which appears active.

Flight holes appear recent

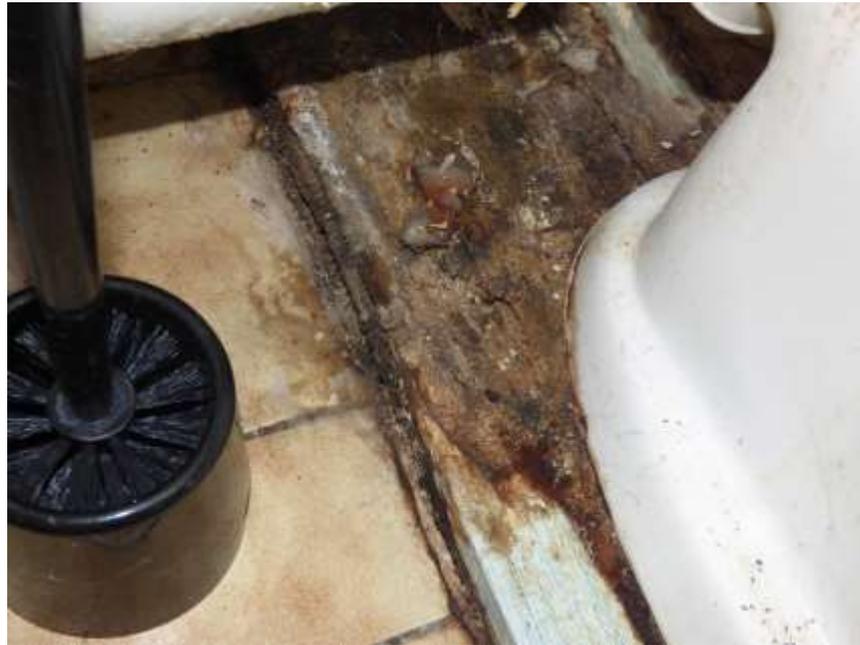
Rot to WC plinth

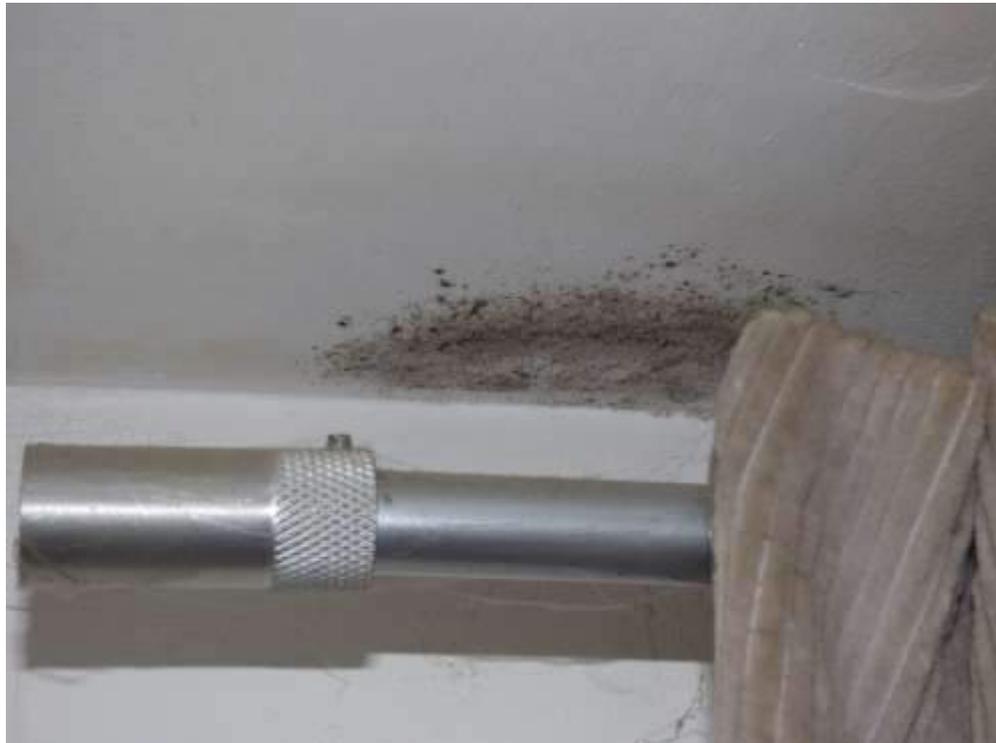
Condensation mould to study ceiling

It is important in this age of property to get rid of any moisture as quickly as possible. We would recommend that extract fans with humidity thermostats are added to the kitchen and the bathroom areas. However careful consideration will need to be given to the position of the external vent covers, so as not to unwittingly spoil the character of the property (alternatively getting into the habit of opening a window for 15 minutes after showering would help).

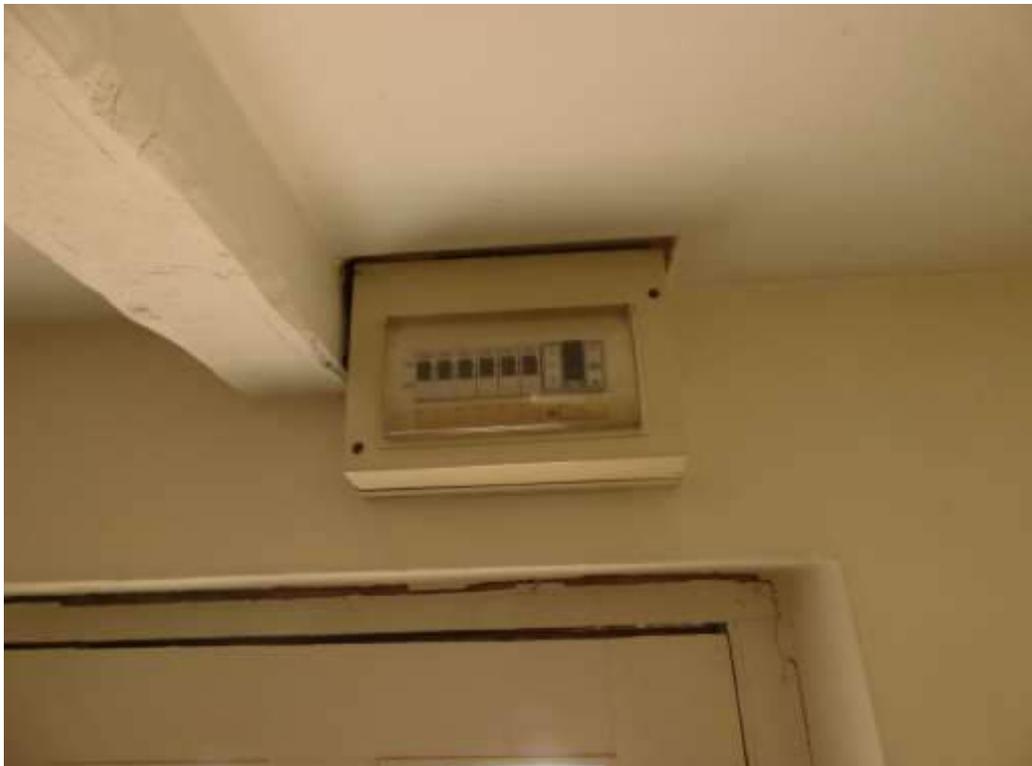
Consumer unit

The main consumer unit comprises an older unit with miniature circuit breakers (MCBs). There is no RCD protection.

The system is unlikely to comply with the very latest standards and some upgrading may be required (the latest wiring regulations were introduced in July 2008), including replacement of the consumer unit with a modern 17th edition consumer unit comprising both miniature circuit breakers (MCBs) and residual current device (RCD).

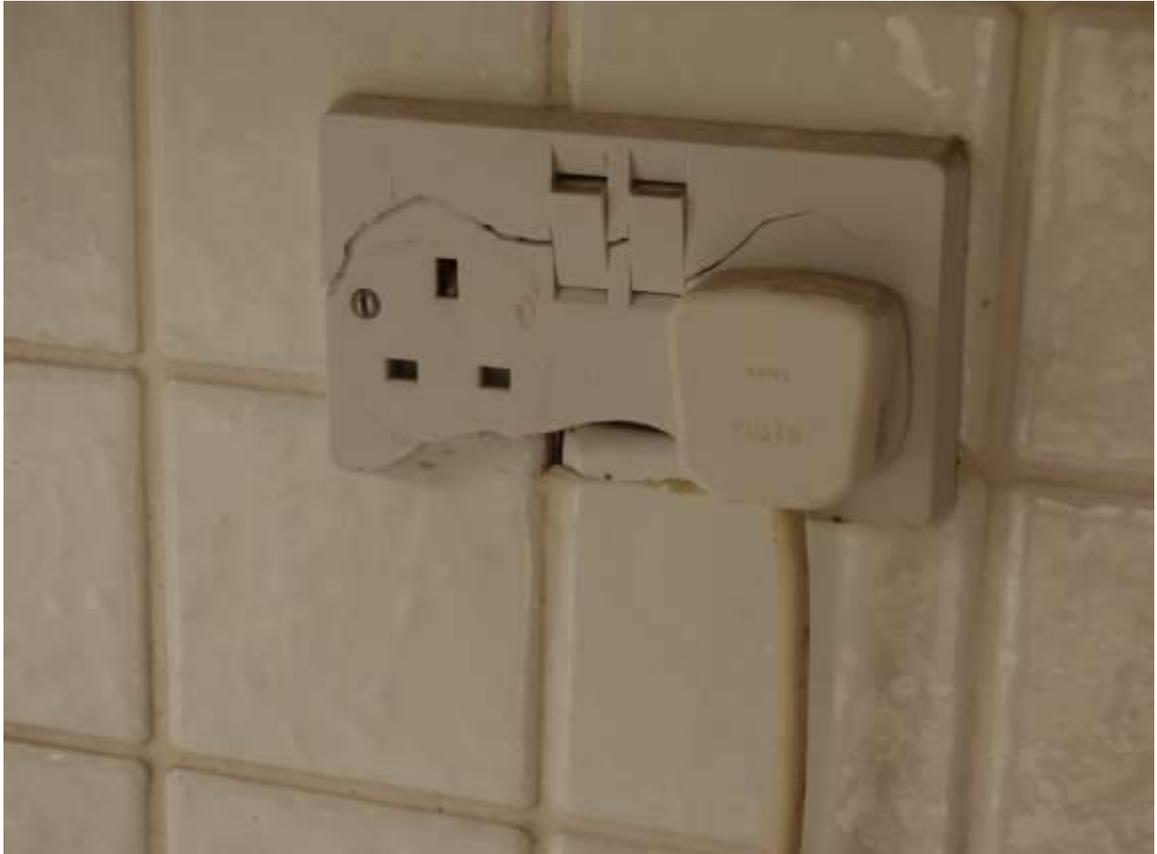
Broken power socket in kitchen

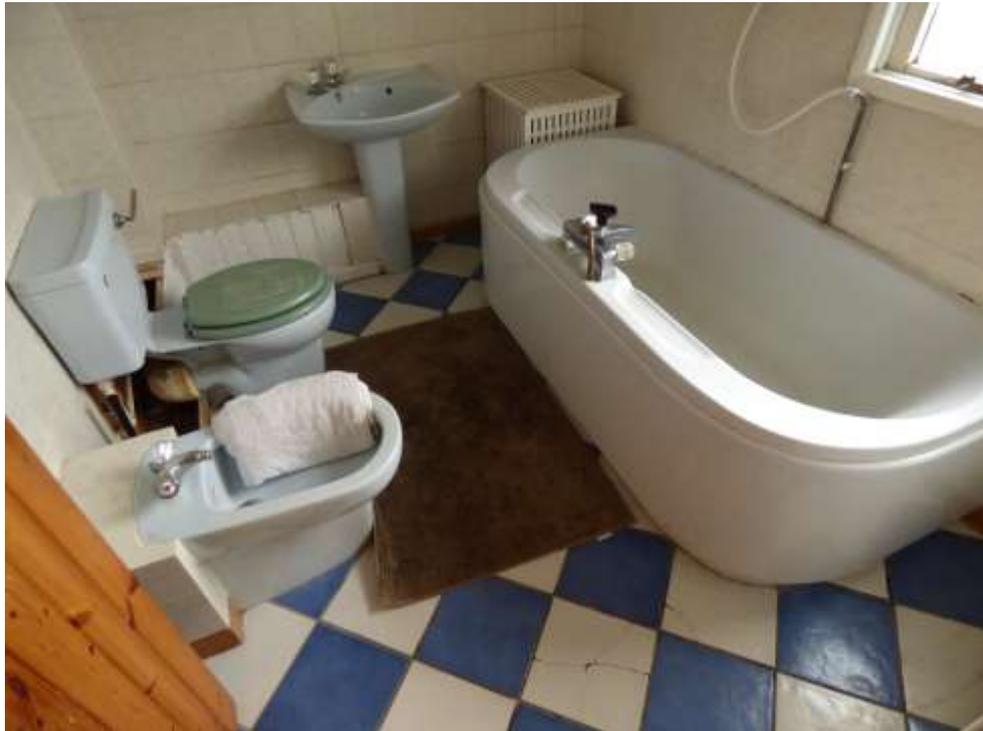
The sanitary fittings are dated and in need of complete replacement, including associated pipework.

We advise that sanitary fittings are often a source of water leakage and periodic attention, particularly to the edge seals, is likely to be needed to prevent problems.
