RICS  
**Building Survey**

Property address	<input type="text" value="Sample"/>
Client's name	<input type="text" value="Sample"/>
Date of inspection	<input type="text" value="04 August 2014"/>

Surveyor's name	Kevin Shaw		
Surveyor's RICS number	1122872		
Company name	Kevin Shaw & Associates		
Date of the inspection	04 August 2014	Report reference number	KS11082014113907
Related party disclosure	We have no links to this transaction.		
Full address and postcode of the property	Sample		
Weather conditions when the inspection took place	It was dry and sunny at the time of our inspection. This was preceded by a period of generally dry weather. As it was not raining we are unable to comment fully upon the effectiveness of the rainwater fittings.		
The status of the property when the inspection took place	The property was vacant and unfurnished at the time of inspection, although floors were covered with carpets and other fitments.		
Property address	Sample

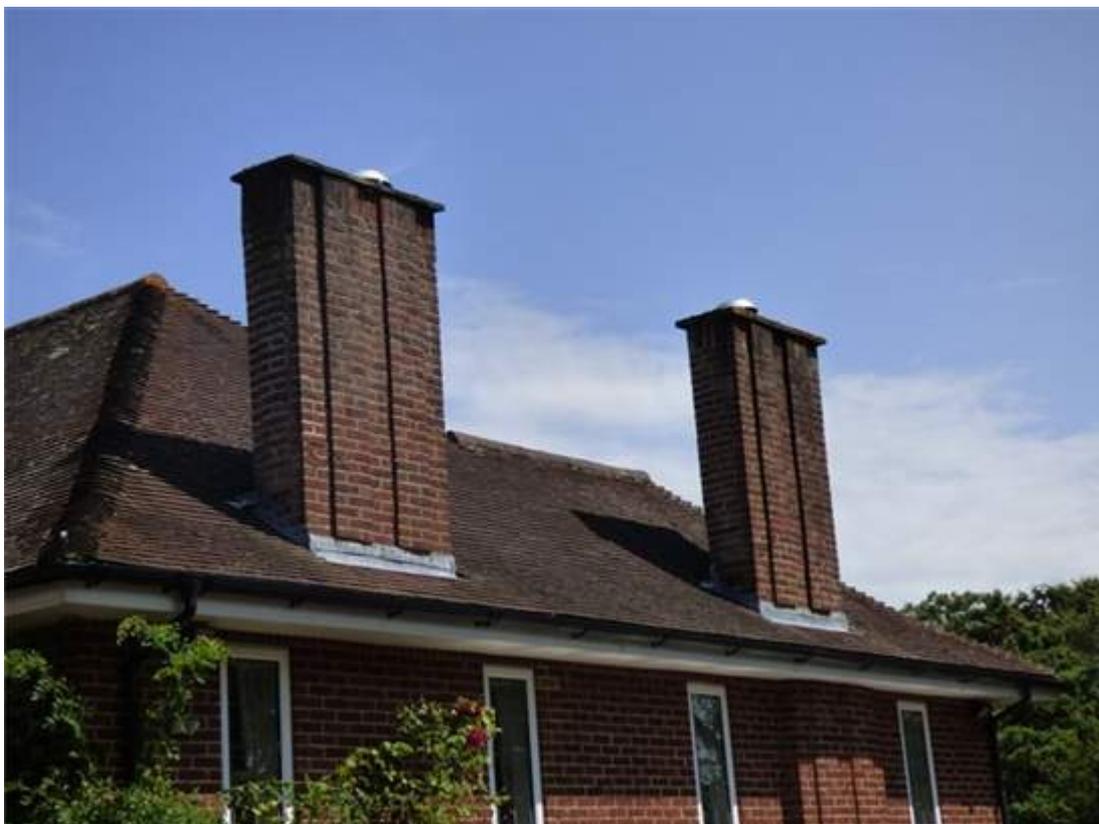
Right side chimney stacks

The chimneys all appear to be in a structurally sound condition with no evidence of any unacceptable thermal cracking or deviation from vertical.

The brickwork was generally found to be in a reasonable condition with no significant frost damage or deterioration apparent. The pointing is weathered in places, which is to be

expected in a property of this age. Some localised repointing repairs will be required in due course. This is not considered urgent.

The lead flashings sealing the chimneys to the roof coverings are in satisfactory condition (where visible), with no signs of significant water penetration. However, stacks of this age do not usually incorporate a proper damp-proof course and even with the flashings in good order, some internal dampness may still occur from driving rain.

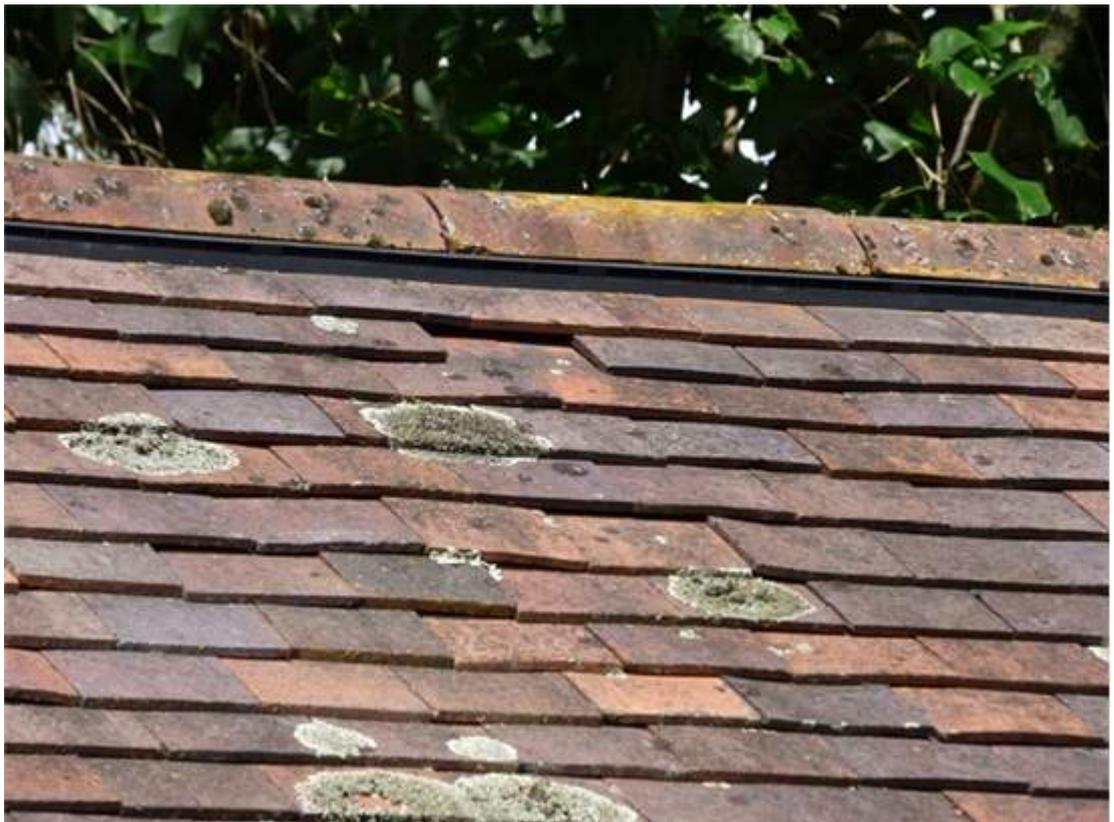
There is the odd slipped tile (annexe roof) which will need replacing

There are a few slipped and missing tiles which should be replaced.

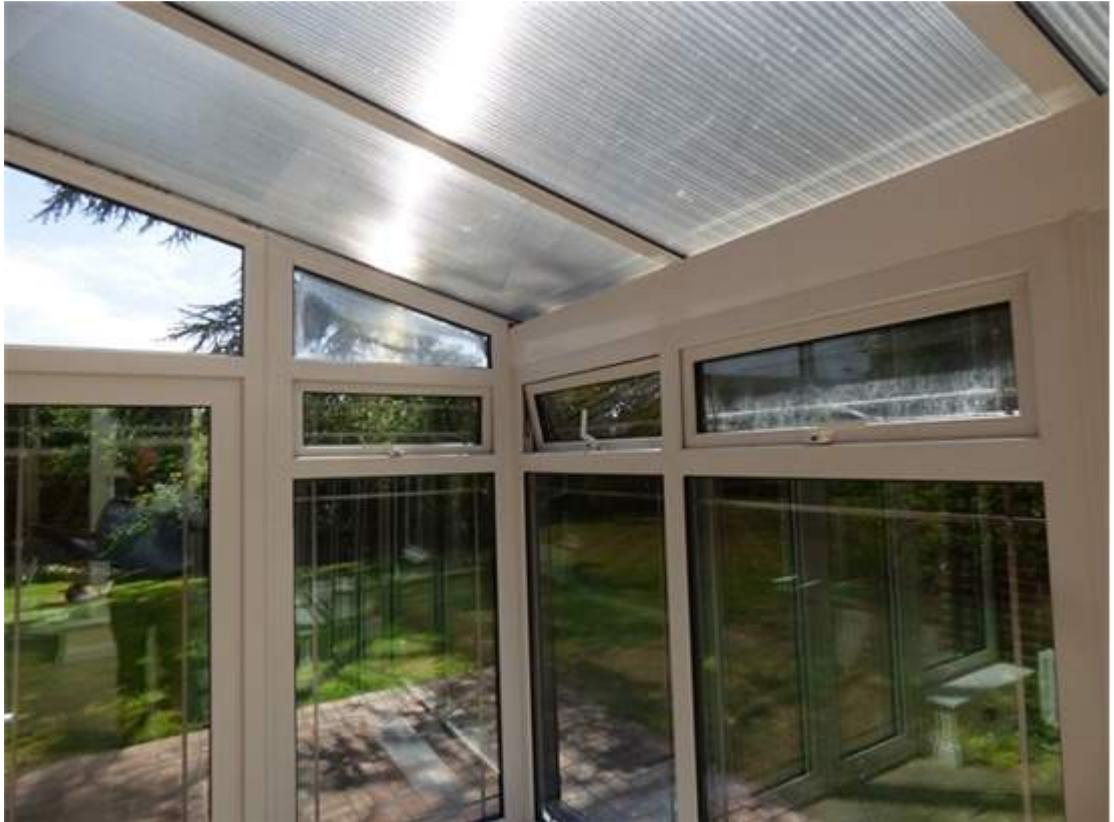
A number of the double glazed panels have failed allowing misting between the panes. Affected units will need to be replaced.

The seals of some of the double glazed units have failed and vapour has entered the void between the panes of glass, resulting in misting and condensation. Whilst unsightly this is not usually serious, although complete replacement of affected units is the only possible solution. Deterioration to other units is likely.

Consideration could be given to replacing the roof with insulating glass eg Pilkington Cervoglass Activ (or similar). However we would anticipate that many prospective purchasers would choose to replace the conservatory, possibly with an orangery. If this is your intention you should obtain quotations so that you can budget for the likely cost.

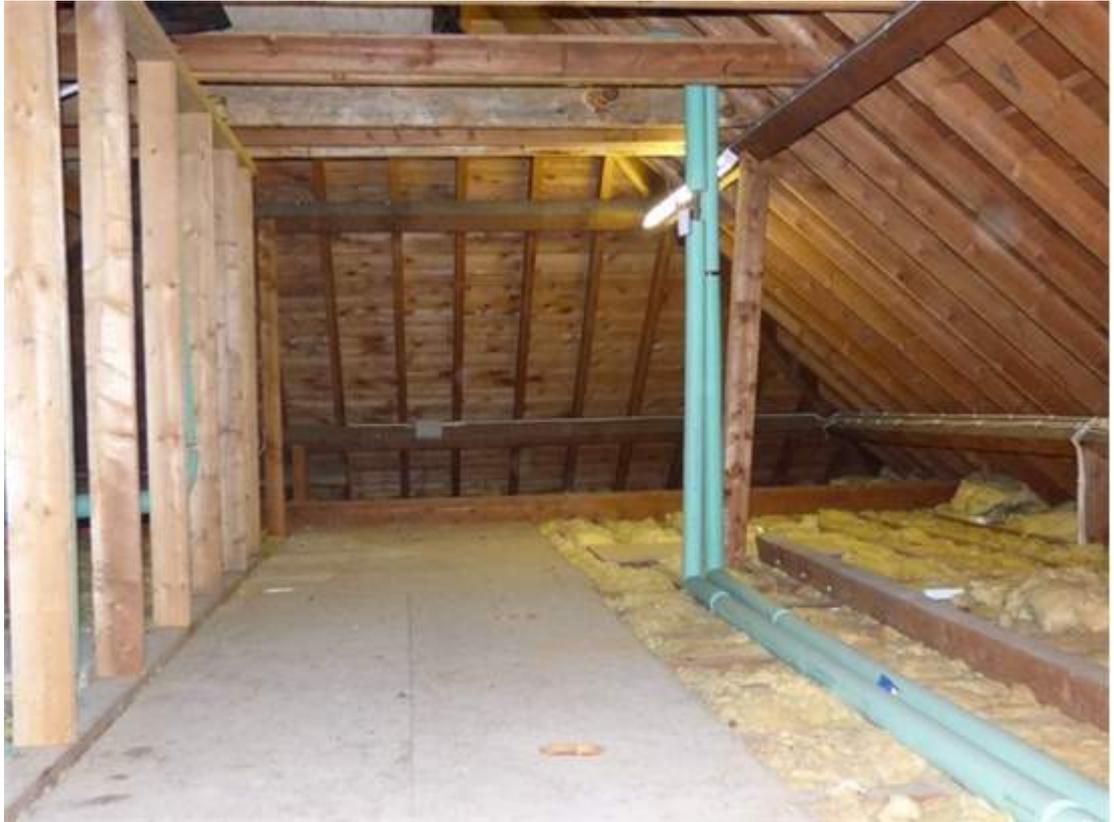
Main roof void. The roof structure comprises a traditional timber rafter and purlin frame overlaid with sarking boards.

The roof structure appears satisfactory with no undue deflection of timbers or other deficiencies.

There is no provision for ventilation of the main roof void. Ventilation of the roof space is considered important to prevent problems with condensation which could lead to timber decay (see section K4 - Ventilation).

Some of the pipework lagging appears to be of asbestos. Asbestos is a hazardous material and you should refer to our comments in section J3 Risks to People.

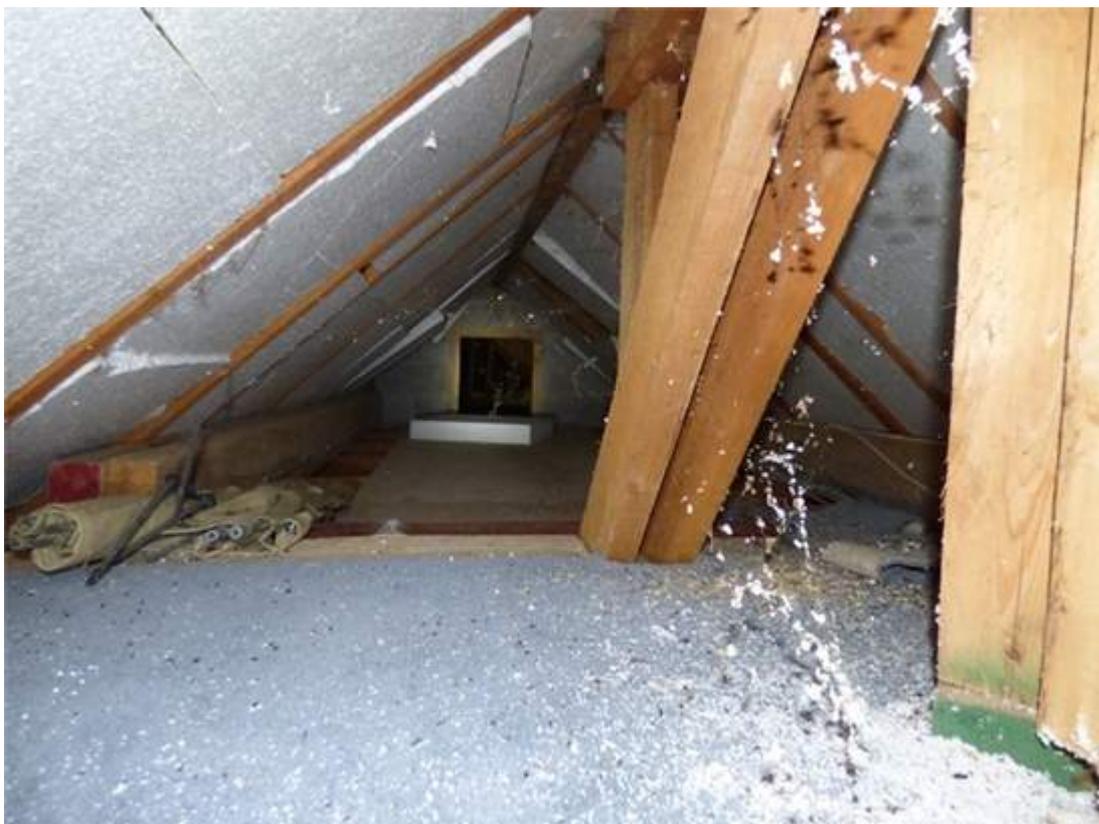
Garage roof void. There is evidence of mice infestation and poison should be laid. Polystyrene insulation sheets may be a potential fire hazard unless pretreated with fire retardant additive. This should be checked and replaced if necessary with PIR insulation boarding.

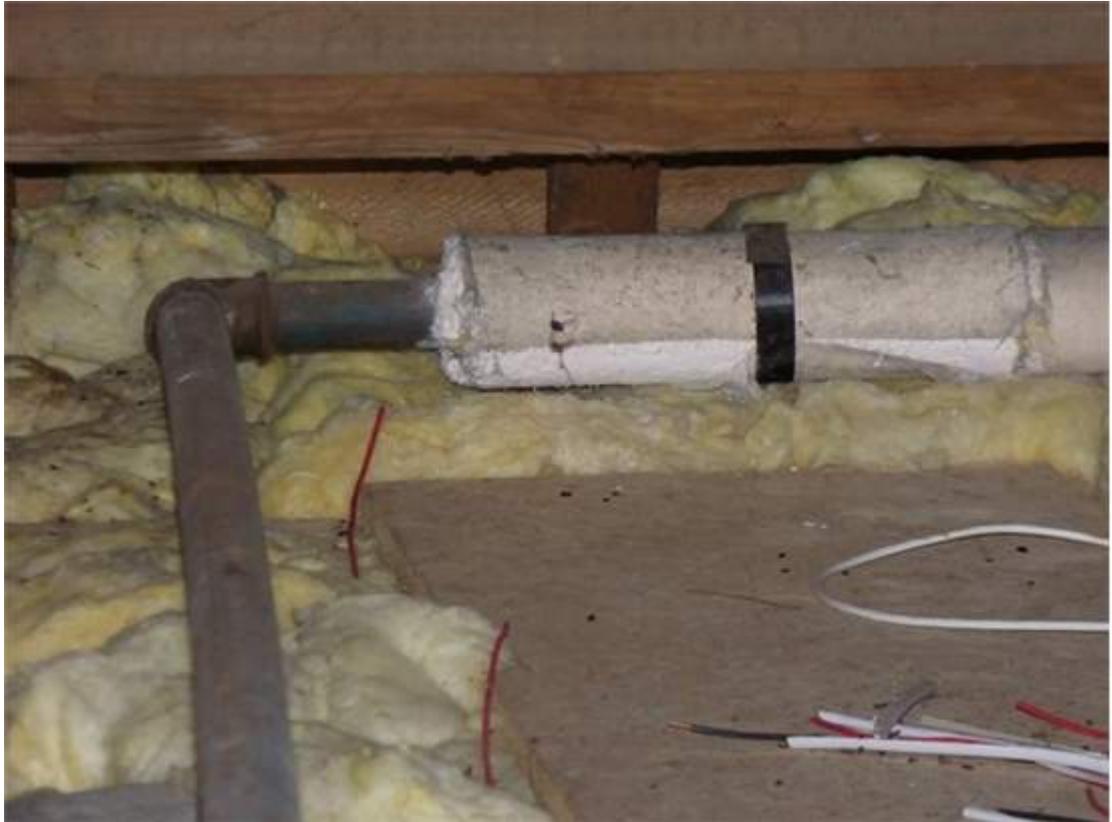
Lagging appears to be of an asbestos containing material (ACM)
