BUILDING SURVEY

Brockenhurst

**KEVIN SHAW & ASSOCIATES
CHARTERED SURVEYORS**

Inspected on XXXXXXX

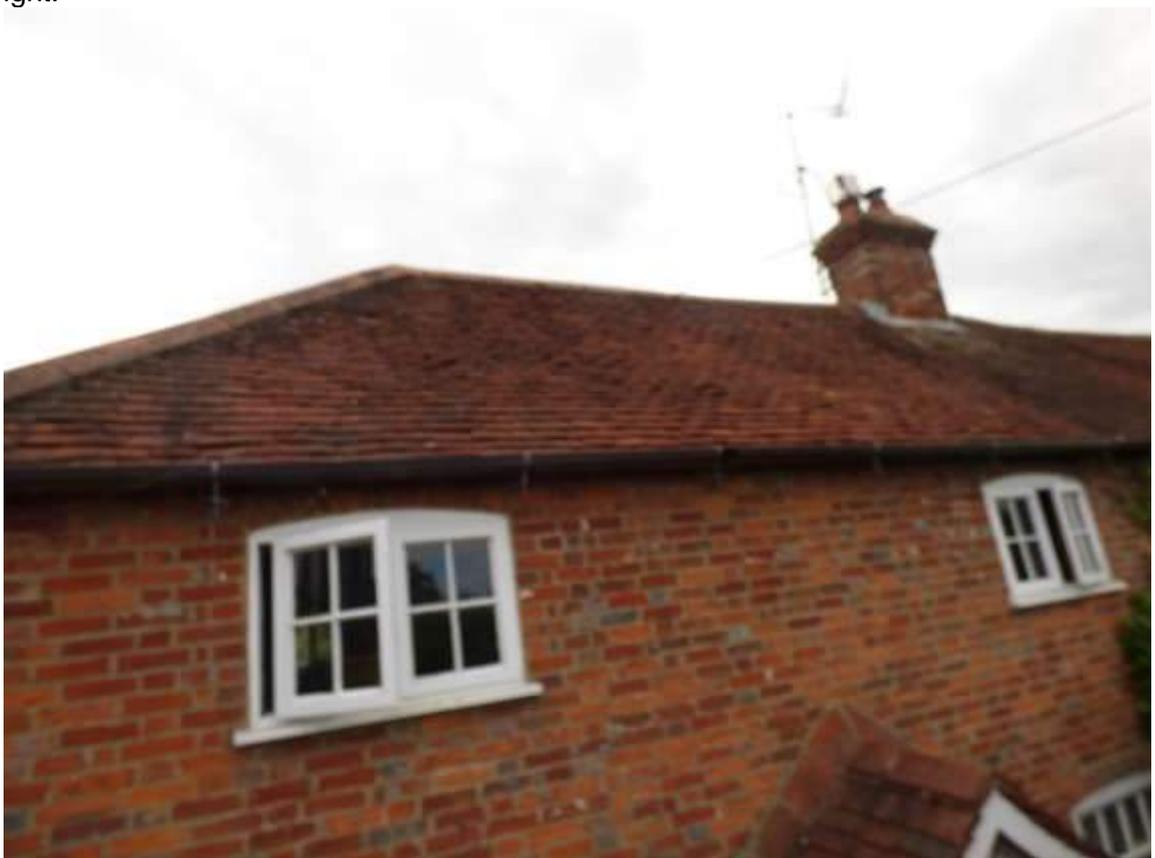
Front roof slopes

The main roof is covered with plain clay tiles and finished with angular clay ridge and hip tiles bedded in mortar. To the rear of the property at the abutment of the main roof slopes a sloping metal lined valley was noted.

Externally, the main roof slopes over the property were noted to be reasonably even and free from any undue distortion, deflection or distress which suggests that the roof framework is dealing adequately with the imposed load of the roof covering.

The roof tiling is in reasonable order considering its age, although inevitably there are a few slipped, missing and broken tiles, which will need replacement. In view of the age of the roof, ongoing replacements must be expected.

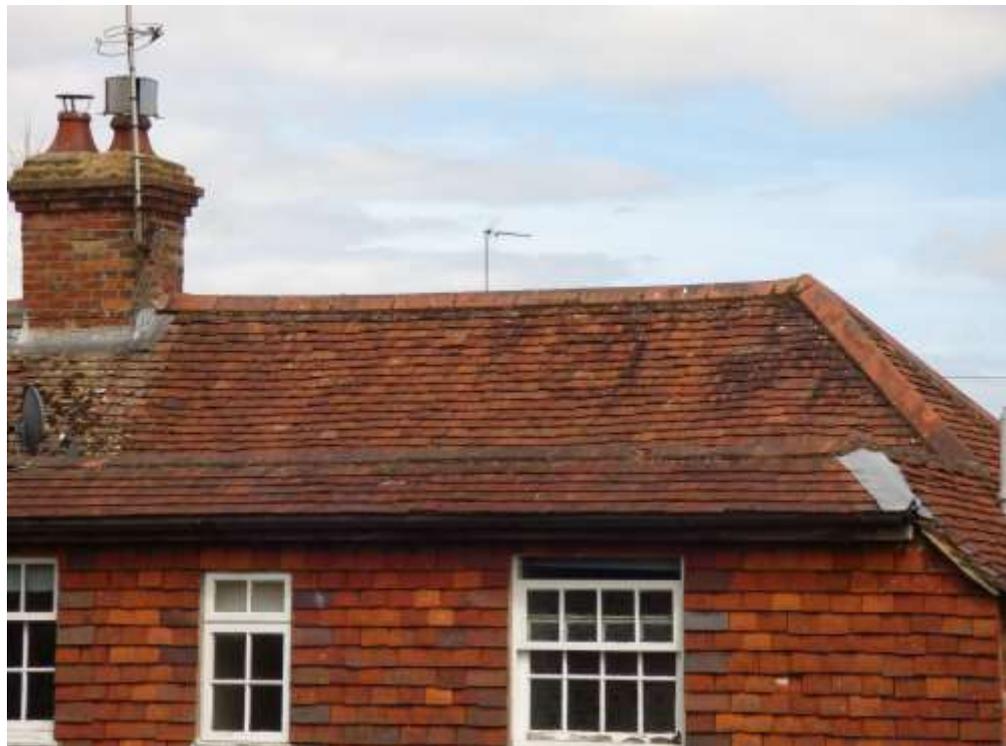
Rear roof slopes

Whilst all ridge and hip tiles were noted to be in place the mortar pointing is cracked and weathered in places. No urgent repairs are required at this stage, as none of the tiles appear to be working loose. However these tiles are often dislodged in high winds and for safety they should be periodically checked and re-fixed, as found necessary.

Moss growth is present on roof slopes. This can impede the run-off of rainwater, lead to gutter blockages and cause water penetration into the roof void, which in turn may lead to rot or other defects in nearby timbers. Occasional cleaning down will be needed. Care should be taken as some damage to the coverings may occur when removal is undertaken.

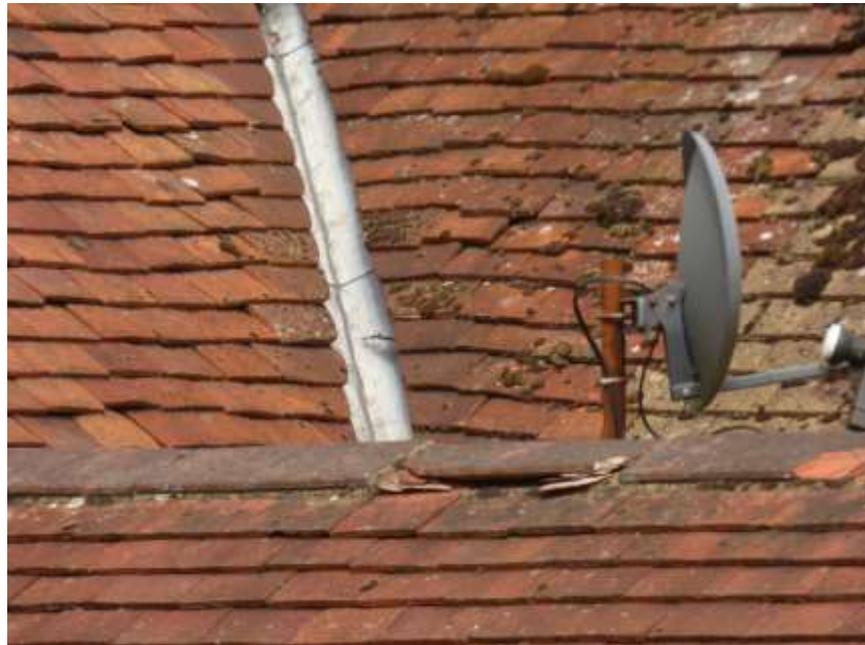
Lead flashings seal the chimney stack to the tile roof coverings. As mentioned earlier the flashing to the rear of the stack is poorly detailed.

There is a lead lined sloping valley to the rear of the building which discharges onto the flat roof. The lining appeared to be satisfactory. Rainwater from the flat roof appears to discharge to a felt valley between the two properties (assuming that there is an adequate fall). The metal flashing beneath the felt has slipped and requires re-securing.

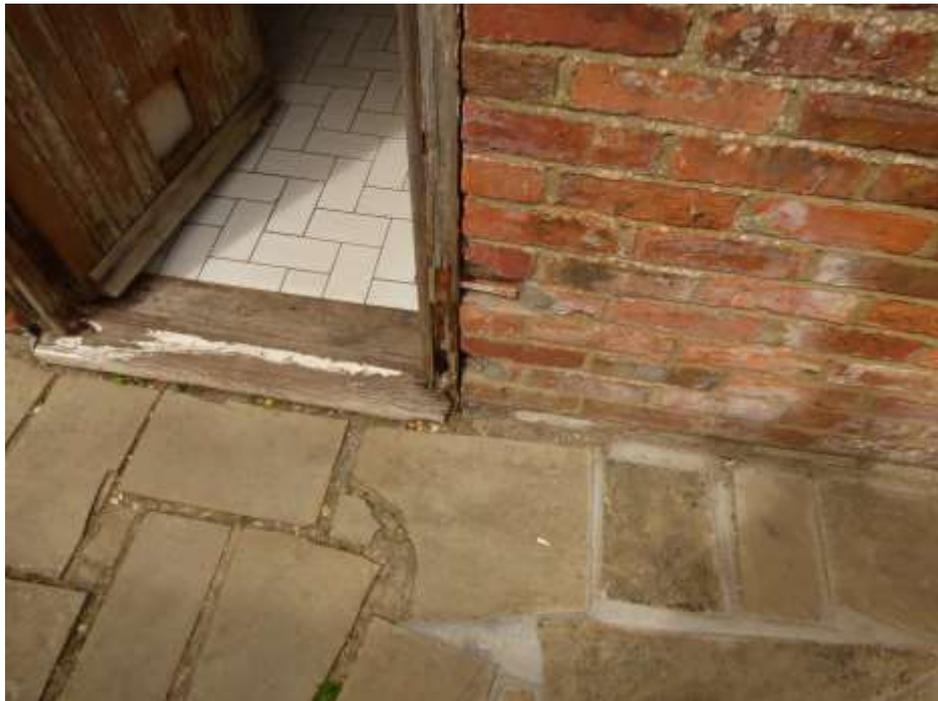
As mentioned earlier the external joinery has been neglected and timber decay was noted to the windows and doors. Repairs/replacements are required.

The kitchen and French doors are in poor condition and will need to be replaced together with their frames. Replacement door frames will need to be installed by a FENSA registered contractor or Building Regulation approval obtained.

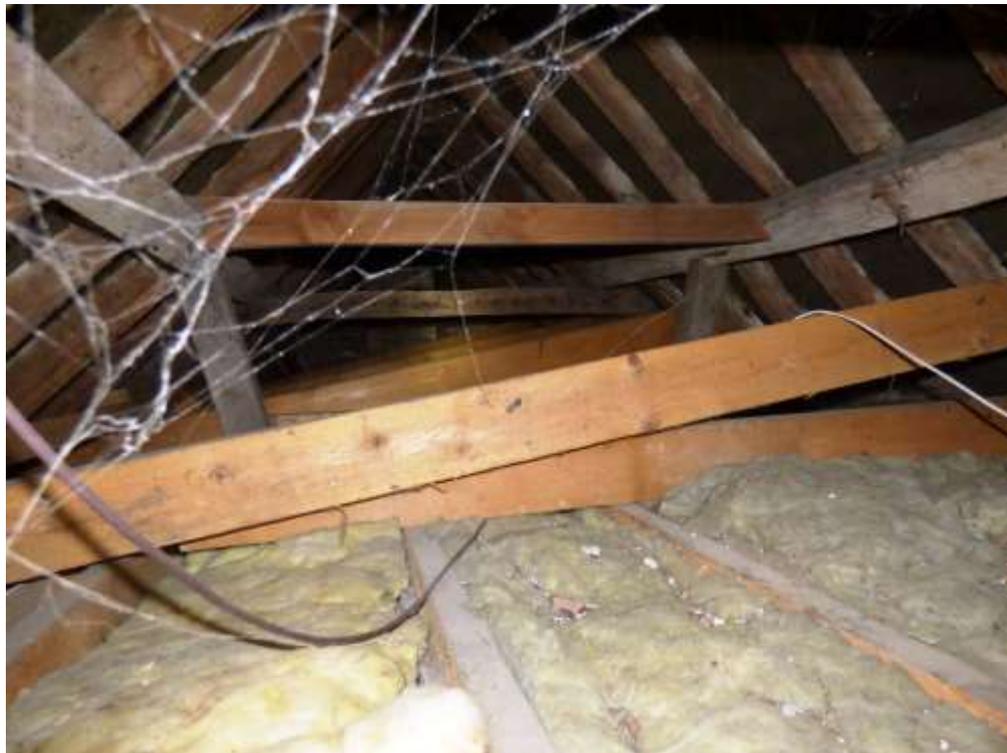
Main roof void – showing additional supporting timbers

The main roof is rectangular in plan, pitched to a central ridge running from left to right. The roof structure comprises a traditional rafter frame incorporating hipped timber rafters, principle rafters and purlins provided at right angles providing support. The original frame has been strengthened with additional collars, struts and ties.

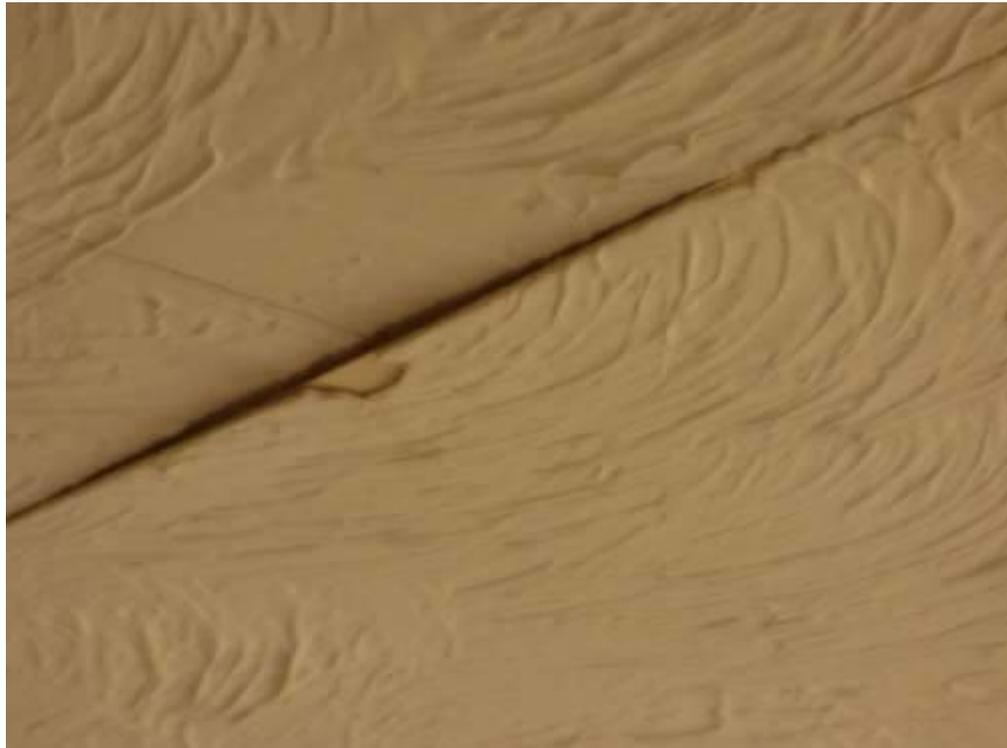
The plasterboard ceilings are generally in fair condition, with no significant defects. There are some shrinkage and differential movement cracks, mainly at corners and

joints. These cracks are not of a structural nature and only minor filling and decoration will be required.

It should be noted that redecoration of Artex is a time consuming procedure and that in its early form it can contain a small amount of asbestos (although this cannot be definitely confirmed without laboratory testing). This material is considered safe under normal circumstances, providing it remains undisturbed. Therefore, the finishes should not be worked or sanded, as this may cause the release of fibres. If a smooth finish is required, re-plastering is advised. However, if future removal is required, basic precautions should be taken (see further information at www.hse.gov.uk). The waste should be double wrapped in polythene, labelled and taken to an appropriate disposal site. At present, there is no requirement for this work to be undertaken by a licensed asbestos removal contractor.

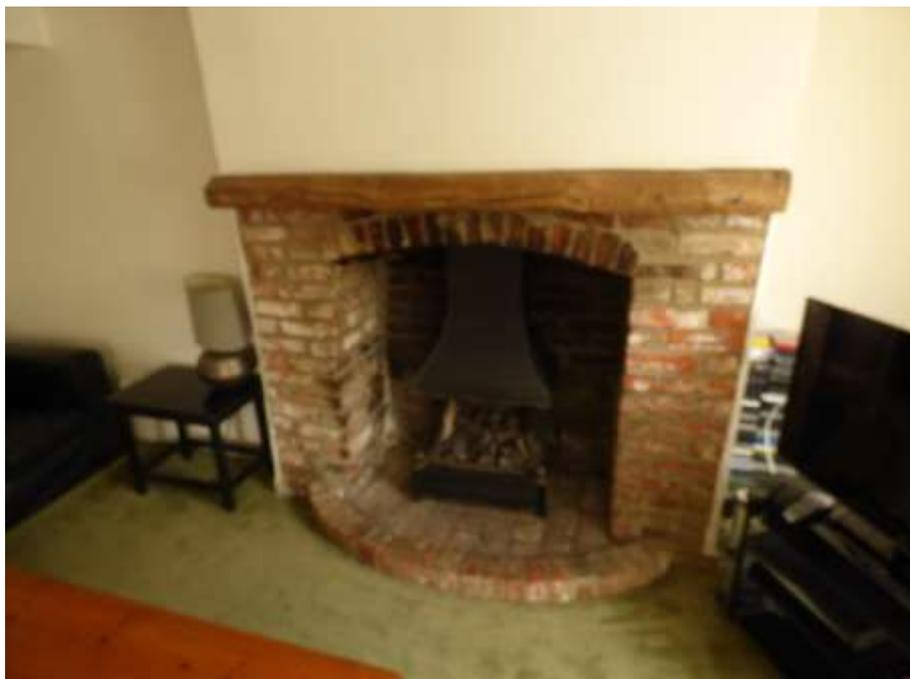
Gas coal effect fire

In the living room there is a brick fireplace with gas coal effect fire and hood. The

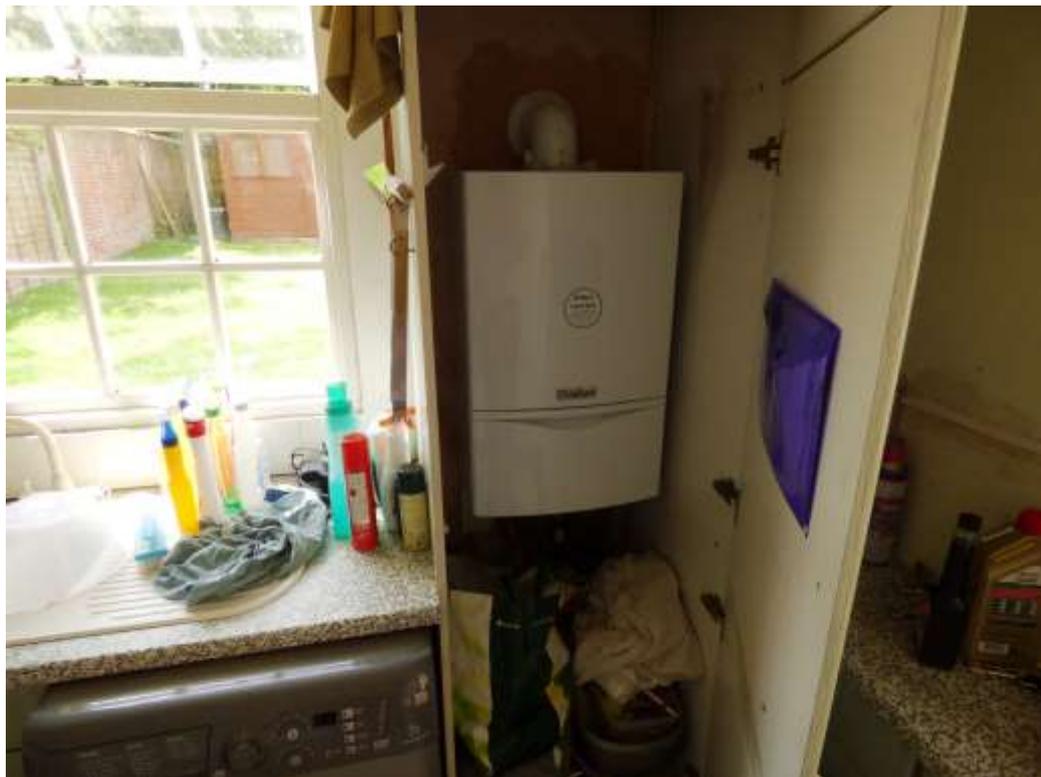
Central heating is provided by a modern wall mounted gas fired *Vaillant ecoTec plus831* combination boiler (condensing) located in the utility. Heating controls include a built in programmer and room thermostat in the rear lobby area.

Typically we are finding that floor mounted boilers are lasting 25 to 30 years (assuming they are maintained regularly), the modern combination boiler (or combi boilers as they are commonly known) are lasting 10 to 20 years and the jury is still out on the new condensing boilers..

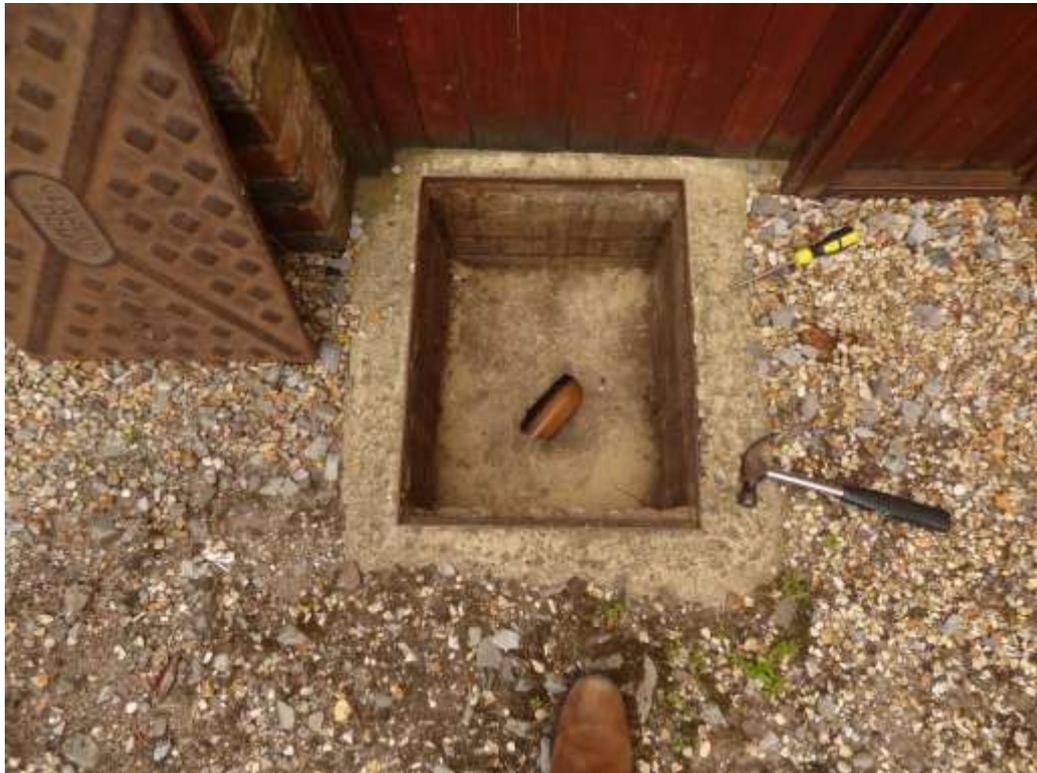
Rear chamber serving the en-suite bathroom
