RICS  
**Building Survey**

Property address	<input type="text" value="Sample"/>
Client's name	<input type="text" value="Sample"/>
Date of inspection	<input type="text" value="04 August 2014"/>

Surveyor's name	Kevin Shaw		
Surveyor's RICS number	1122872		
Company name	Kevin Shaw & Associates		
Date of the inspection	04 August 2014	Report reference number	KS11082014113907
Related party disclosure	We have no links to this transaction.		
Full address and postcode of the property	Sample		
Weather conditions when the inspection took place	It was dry and sunny at the time of our inspection. This was preceded by a period of generally dry weather. As it was not raining we are unable to comment fully upon the effectiveness of the rainwater fittings.		
The status of the property when the inspection took place	The property was vacant and unfurnished at the time of inspection, although floors were covered with carpets and other fitments.		
Property address	Sample

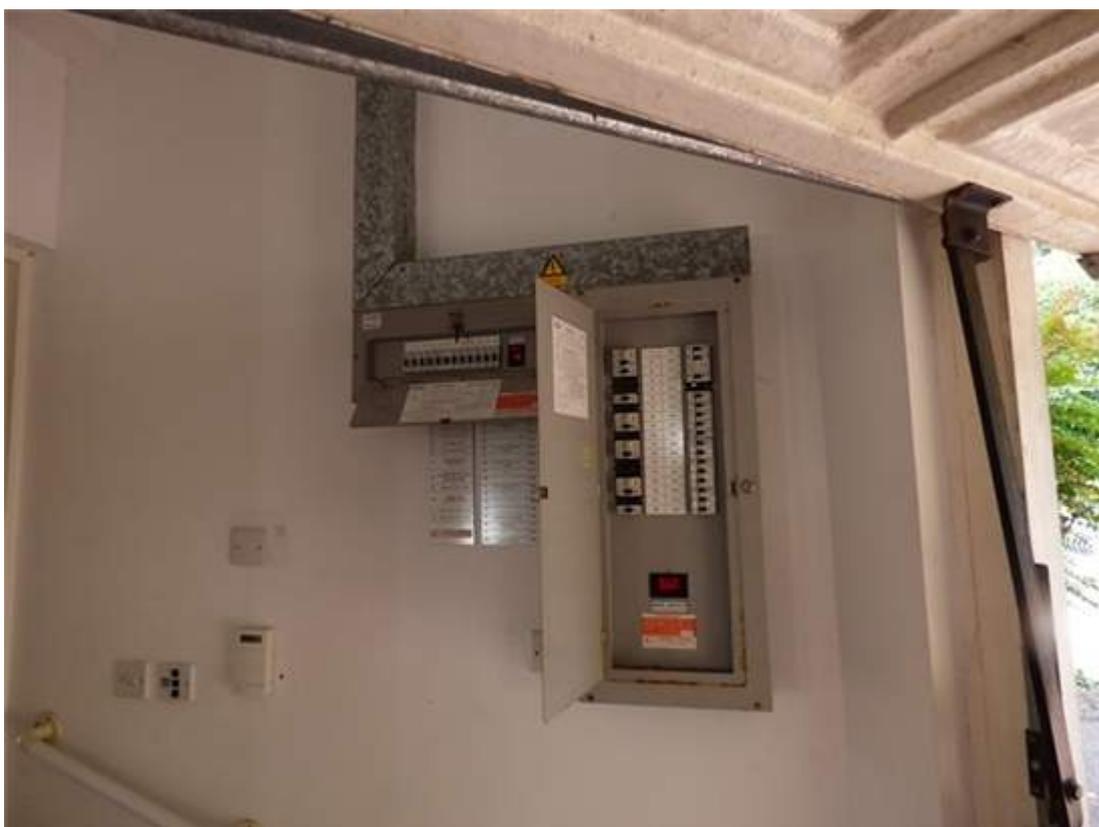
### Consumer units

We recommend the consumer units are replaced with new consumer units fully compliant with the 17th Edition of the IEE Wiring regulations, ideally with RCBOs for each circuit.

The downlighters above the baths do not appear to meet IP65 requirements. They should be checked and replaced as necessary.

We have not seen a copy of a recent test certificate. In the absence of a recent test certificate we recommend that you follow the ESC's advice and arrange for the electrical installation to be checked by a registered electrician and an electrical installation condition report (EICR) prepared. Tests to include insulation, polarity, and earth continuity, with a check to ensure that all plumbing and gas services are bonded to earth. Any works necessary to comply with British Standard 7671: 2008 (as amended) should be undertaken.

Condition rating 3 Further Investigation
